Log Drop Evaluations at Timbers Creek and Rock Creek

Mile High Flood District

October 08, 2021

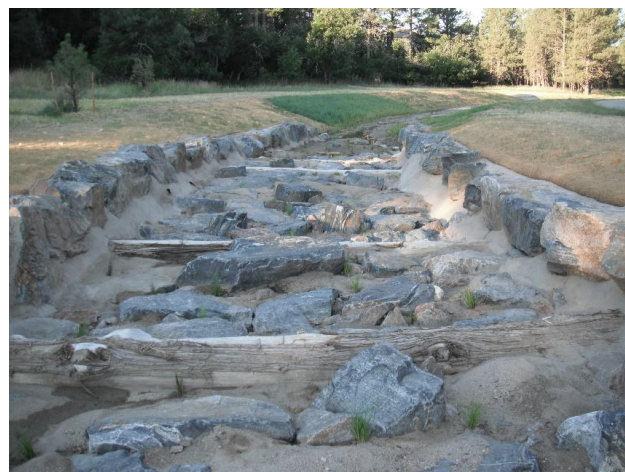
Figure 4: Post Flood Repairs

In 2012, the project site received flood damage before vegetation could be established in the very sandy soils. The logs themselves were not damaged nor undermined, but there was significant scour and riprap transportation. In response, the site was repaired in 2013. The areas between logs were filled with 4-foot boulders, grouted to two-thirds the height of the boulder to allow for sediment deposition and vegetation. The four interior logs received sheetpile to provide additional seepage protection. The low flow channel was lined with grouted boulder walls as well (see Figure 4). Due to the dry, sandy nature of Timbers Creek, revegetation of the channel was a challenge and it took several growing seasons to properly establish.

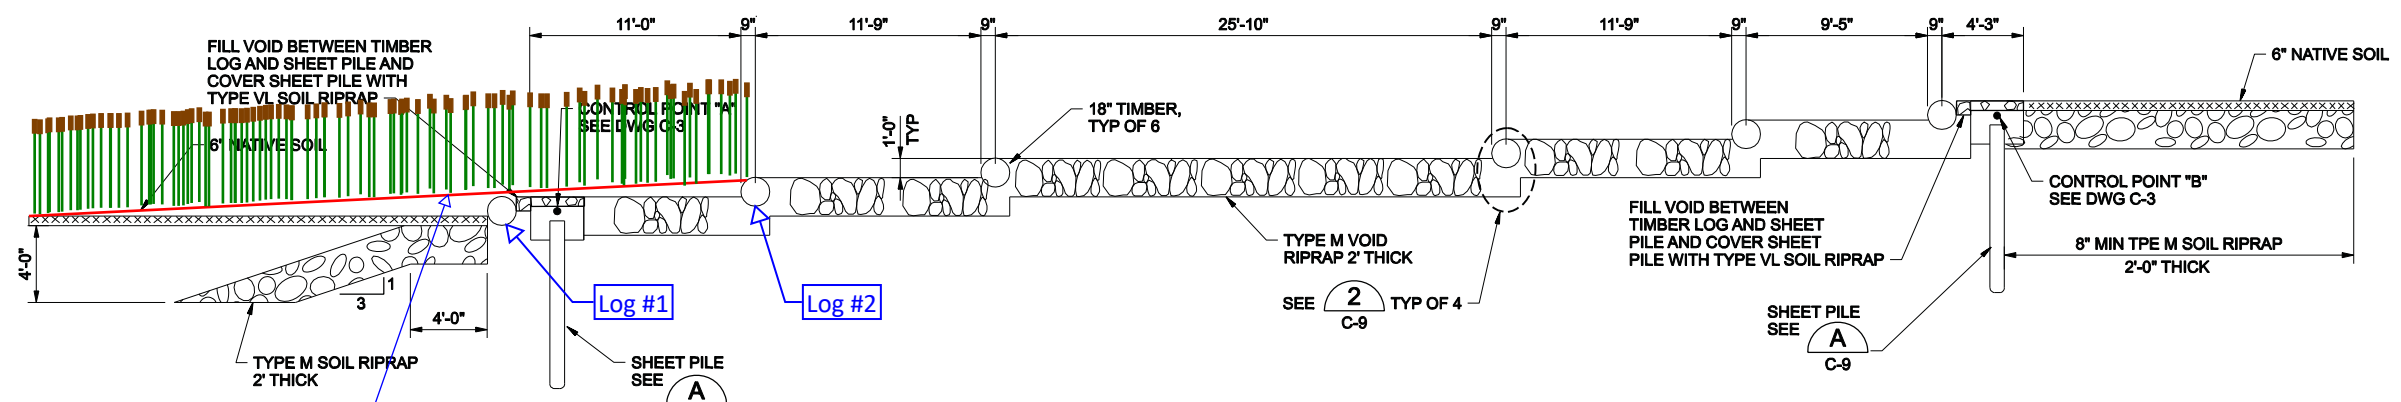
PROFILE A
1"=5' C-9

The channel has formed a new slope from the top of Log #2 downstream to the natural channel bottom. The extent of this revised channel bottom is unclear.

- The channel slope between Log #2 and Log #1 appears to have found a natural stable condition with the aggradation of sediment and establishment of vegetation, see **Appendix B**. We recommend that, for the moment, the vegetation be left alone as channel stability has been achieved and an ecosystem has established. At the same time, we recommend continued observation and evaluation of the vegetation advancement as it relates to stream stability and function within the drop structure.

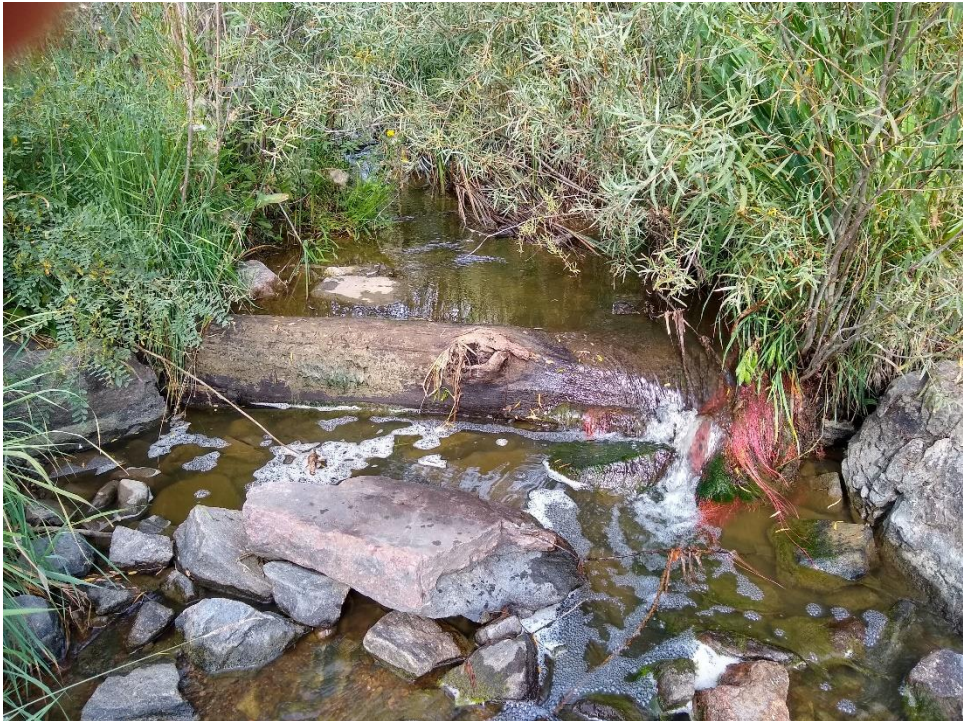
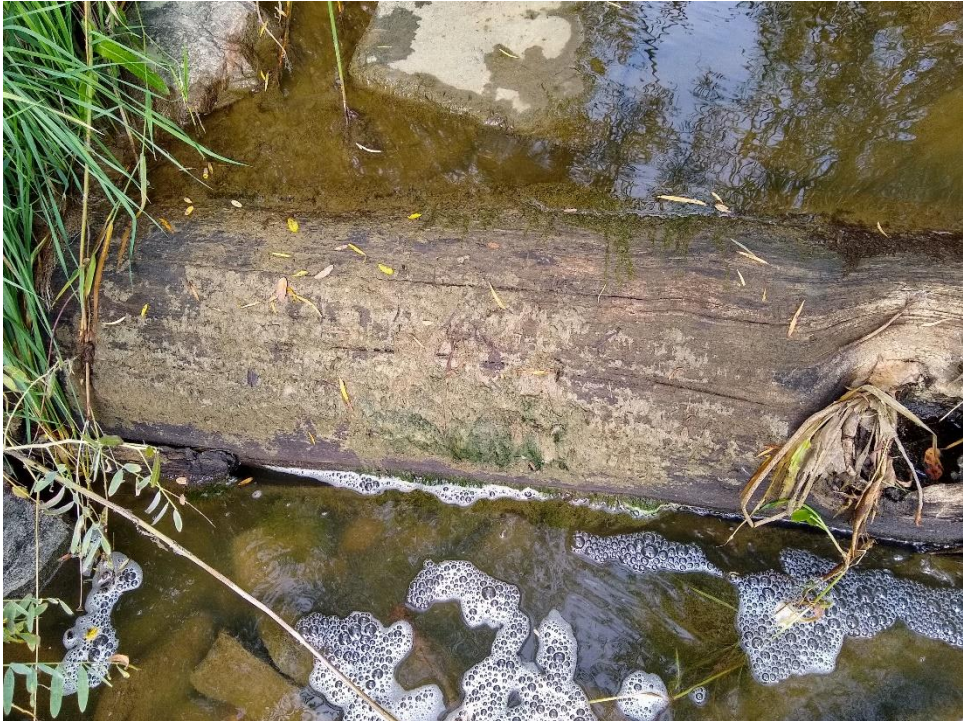
LOG DROP 2 – NATURAL LOG DROP (Cottonwood)

The pine and cedar log drops are performing well and the log integrity appears strong. The log drop to monitor more closely is Drop 2, which used a cottonwood log. Due to the irregular shape of the log, during low-flow conditions a portion of the log is exposed to the air and can dry out. This can accelerate the biodegradation activity and could decrease the longevity of the log. As part of this pilot project, it was known that cottonwood logs are more susceptible to biodegradation and the center of the trunk is often hollow. The fact that part of the log will experience wetting and drying cycles will be informative to determine if the longevity of the log is compromised. Jacobs recommends that this drop be monitored more closely to determine if it experiences deterioration faster than the other logs. This information will be especially important since cottonwood trees would be the most likely species to be used by the District on future projects.
