GREEN ROOF PLANT TRIALS 2011

DENVER BOTANIC GARDENS

Green Roof Plant Trials 2011 prepared by:
Amy Schneider, Horticulture Department
Denver Botanic Gardens
November 17, 2011

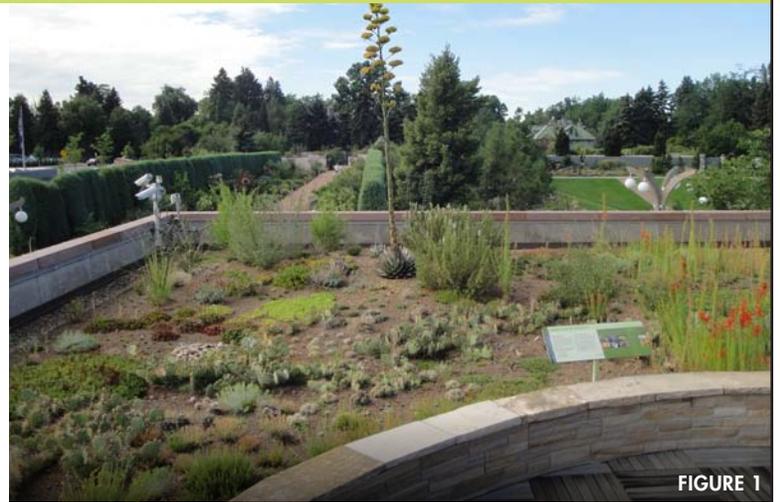
FIGURE 1

The roof spans approximately 1,180 square feet and faces south. It receives no shade during the day. There is a three-foot high concrete wall surrounding the garden on the east, west and south sides. Another wall, built to separate the patio viewing area from the garden itself, is approximately 18 inches high (see Figure 1).

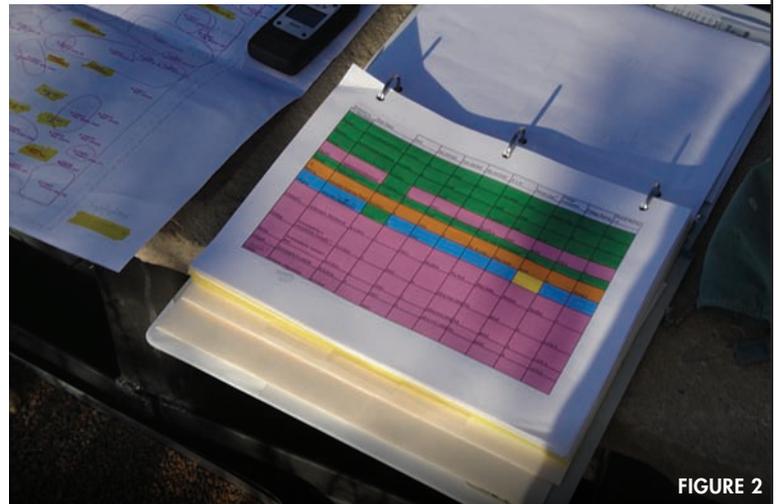
FIGURE 2

Species are selected for a variety of characteristics including their rate of establishment, their environmental tolerances, their ease of availability and/or propagation, their aesthetic value and their potential wildlife habitat value. Since 2010, the data collection categories include plant height, spread, foliage appearance, bloom time and survival counts, ending with an overall rating for each species (Figure 2).

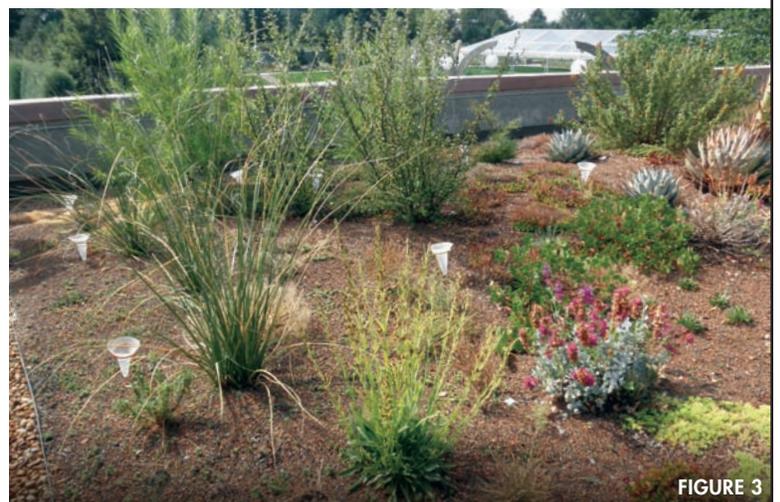
FIGURE 3

In 2010, the Green Roof received 0.5 inch of irrigation per week, starting the first week of July and continuing through the end of October, for a total of approximately 8 inches of supplemental irrigation for the year. Figure 3 shows an irrigation audit in 2011, re-determining the length of time irrigation has to run to get 0.5 inch.

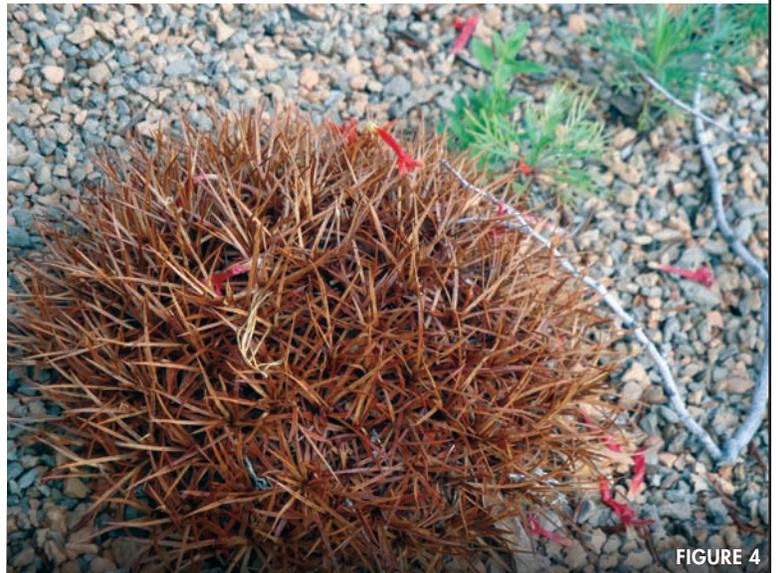
FIGURE 4

The month of July 2011 saw some of the most significant summer rainfall in recent history, a total of 6.65 inches, resulting in no need for July irrigation. It also resulted in the demise of a few species seemingly intolerant of any water at all. Figure 4 shows *Acantholimon armenum* in the far southwest corner of the green roof, all plants except one dead, after almost 7 inches of rain.

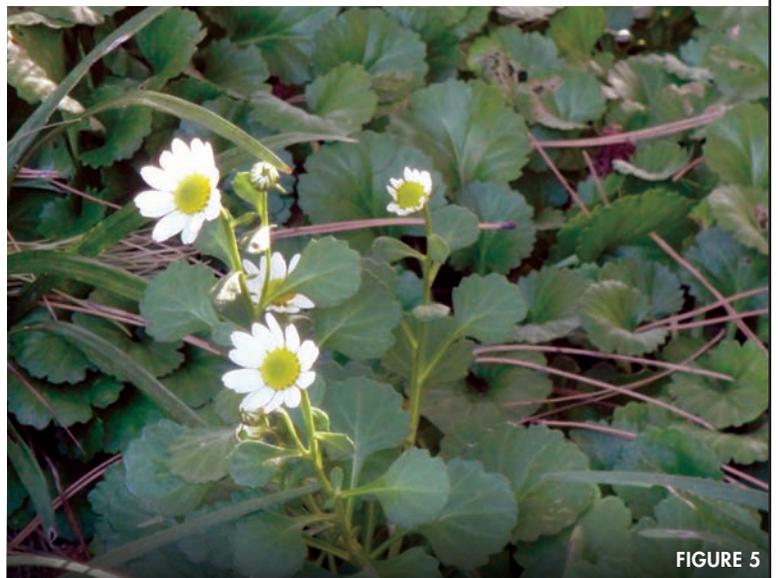
FIGURE 5

The most impressive of these is *Chrysanthemum weyrichii*. Sixteen plants were installed in November 2007 and have grown to form a carpet 8 feet long and 5 feet wide. It is covered with flowers every autumn (Figure 5).

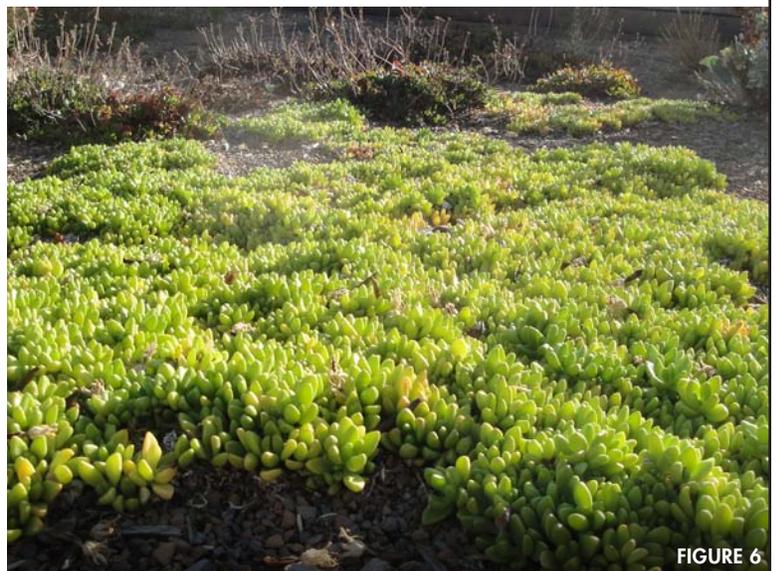
FIGURE 6

Another performer in this category was *Delosperma nubiginum*, planted in November 2007 (Figure 6).

Twenty-one *Delosperma nubiginum* plants formed a 5 x 2.5 foot carpet on the north facing sloped hillside with deeper planting media. In a second spot on the west side of the roof, it has grown at a slower rate in a shallow flat area. The *Delosperma* is also worth noting for two

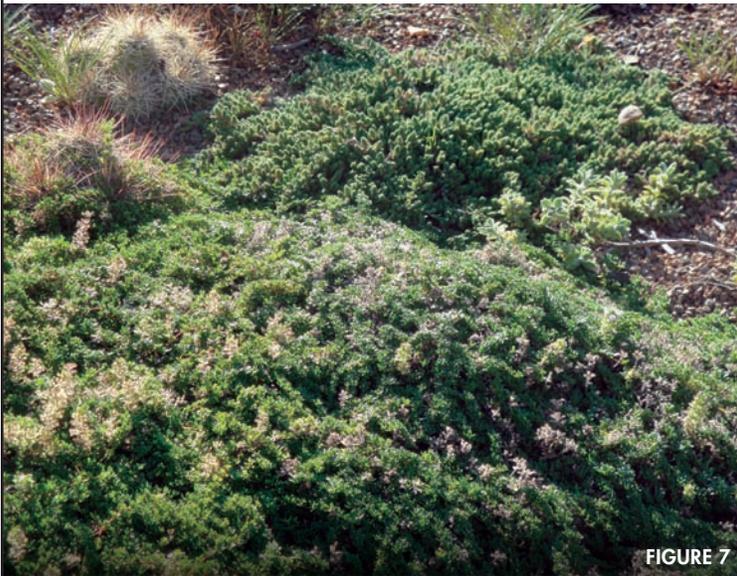
FIGURE 7

other reasons. When it is covered with yellow flowers during June, it attracts hundreds of bees. In the fall, the foliage turns a beautiful burgundy red, adding color to the roof all winter. *Thymus neiceffi* and *Veronica thymoides* (Figure 7) have grown into carpets similar in size to what would be normally expected if they were growing on the ground. This is true of both the *Chrysanthemum* and *Delosperma* as well.

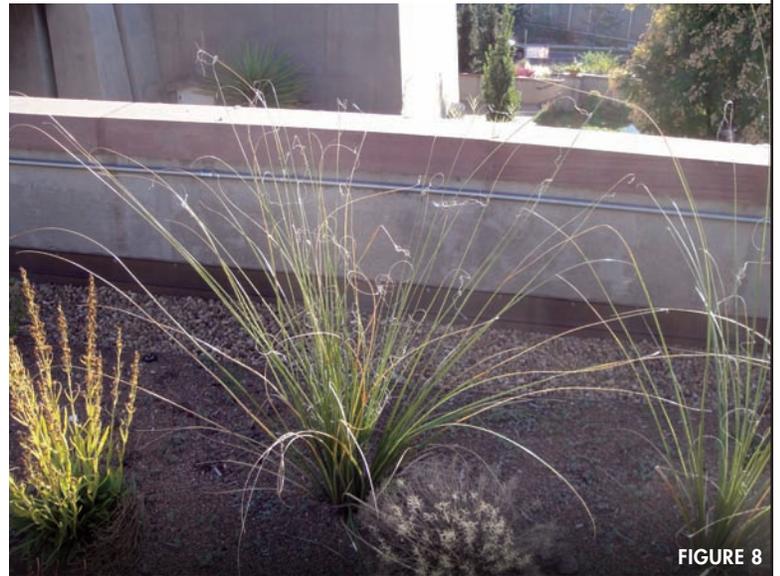
FIGURE 8

Several of the species appear healthy but seem to be growing at a much slower rate than when planted in the ground. This noticeable trait affects several plants on the green roof, including *Hesperaloe parviflora*, *Nolina microcarpa*, and all three species of *Arctostaphylos*. The eight *Hesperaloe* are only slightly larger than they were two years ago, and the *Nolina* (Figure 8) is only 3.7 feet tall after four growing seasons.

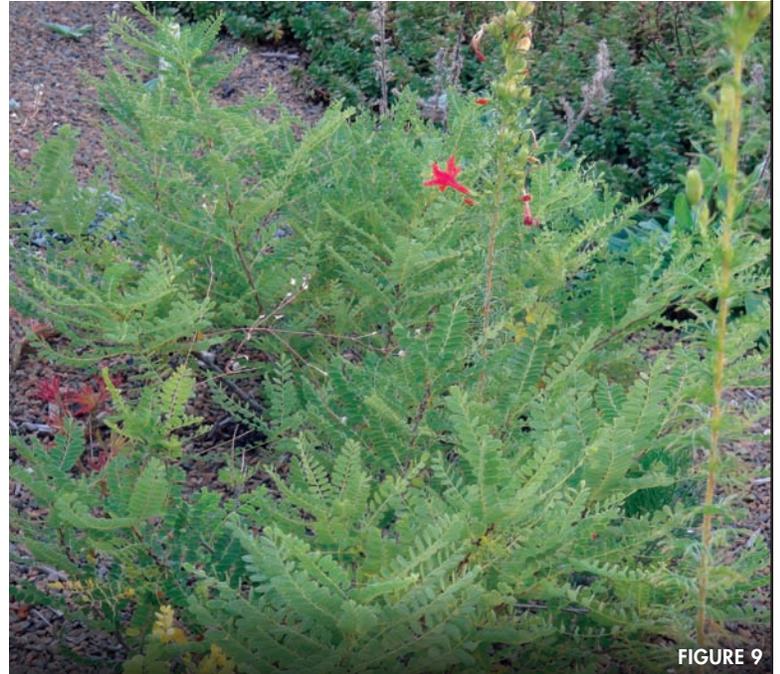
FIGURE 9

The woody shrub *Amorpha nana* (Figure 9), is only a foot tall after three years on the roof. While this growth rate is low and the plants are small, they appear vigorous and green. Their small sizes may be caused by the harsh conditions on the roof and the lack of moisture, shade and nutrition. Both the *Hesperaloe* and *Amorpha* bloomed in 2010 and 2011.

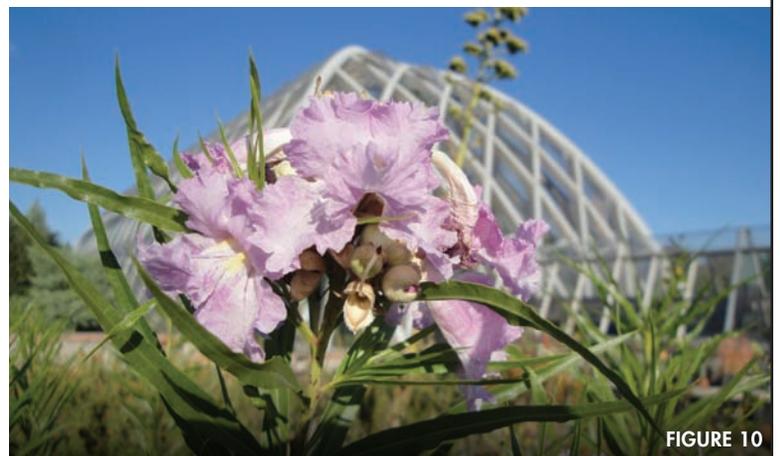
FIGURE 10

The two *Chilopsis linearis* (2007) were grown from wild collected seed from Texas. They were planted from one-gallon containers, and as of September 2011 are both approximately five feet tall and about 2.5 to 3 feet wide, again smaller than expected. They are situated at the top of the berm in the southeast corner in full sun all day. Since they are surrounded on two sides by concrete walls, they get absolutely no circulating air. This is undoubtedly the hottest, driest area on the roof, yet they remain green and bloomed for the first time in 2011 (Figure 10).

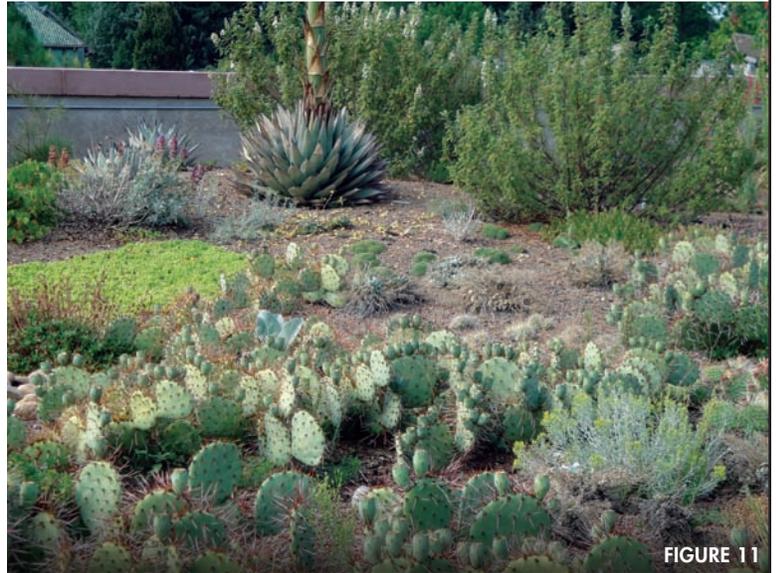
FIGURE 11

More high performing species are the *Opuntia*, original to the 2007 design. There are three species on the roof (Figure 11).

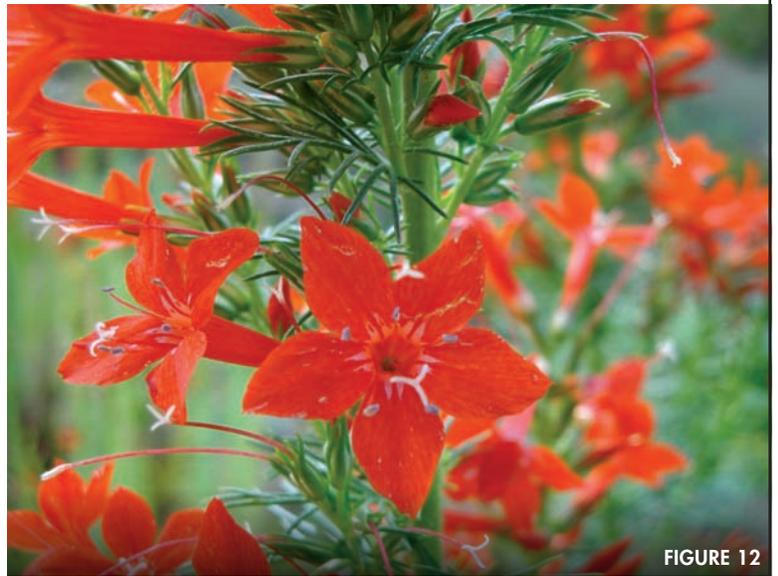
FIGURE 12

One of the clear performers in this 2010 group is *Ipomopsis aggregata* (planted 2010), which is just like the *Ipomopsis rubra* planted in 2008 (Figure 12). *Ipomopsis aggregata* has seeded itself over a 15-foot long area on the entire western side of the roof, with both species growing fairly tall (about 2-5 feet). Their height is providing shade, keeping themselves and their neighboring plants and their roots cool. These plants are a feasting area for hummingbirds, especially in the early morning. In Figure 1, the *Ipomopsis*, with its height of five feet plus and distinctive orange red flowers, is visible over the right side of the roof. This speedy self-sowing has to be monitored since it could easily take over the entire roof in a few years. For the present time, spent stalks are removed each spring and the beds are thinned. On other green roofs this plant may pose some control concerns, depending on the size of the roof.

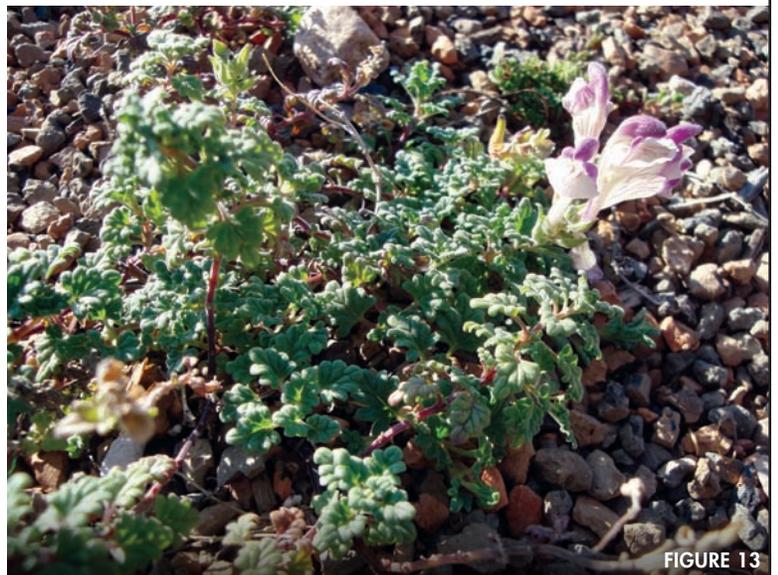
FIGURE 13

One last 2011 planting must be mentioned, due to its amazing establishment rate and almost immediate and continual blooming habit. Twenty 2.5" pots of *Scutellaria prostrata* were planted on June 12, 2011 and were noticeably growing and blooming within a month. While not exactly a carpet former, it is covering the ground around itself while leaving small open areas between its stems (Figure 13).
