FLOODS IN COLORADO

GEOLOGICAL SURVEY WATER-SUPPLY PAPER 997

ROBERT FOLLANSBEE AND LEON R. SAWYER

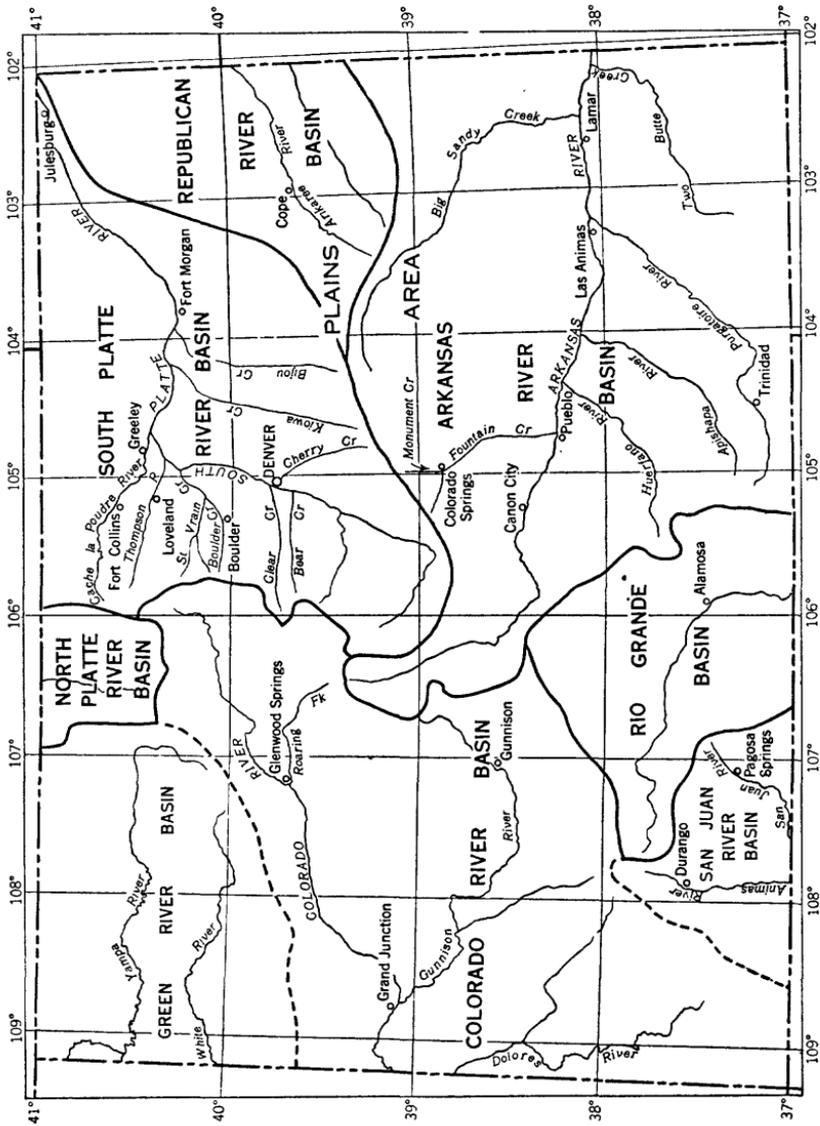
FIGURE 1.—Map of Colorado showing principal river systems and cities mentioned in the text.

Single floods inundating large areas and causing heavy loss of life are rare in Colorado, but many floods of considerable magnitude have occurred, some of which caused loss of life and great property damage. Many of the areas flooded are shown in figure 1.

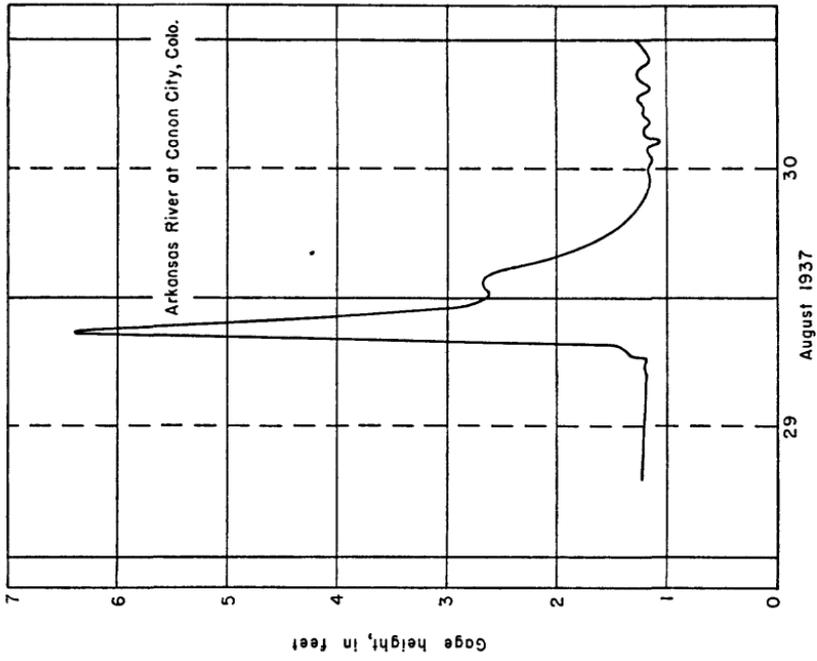
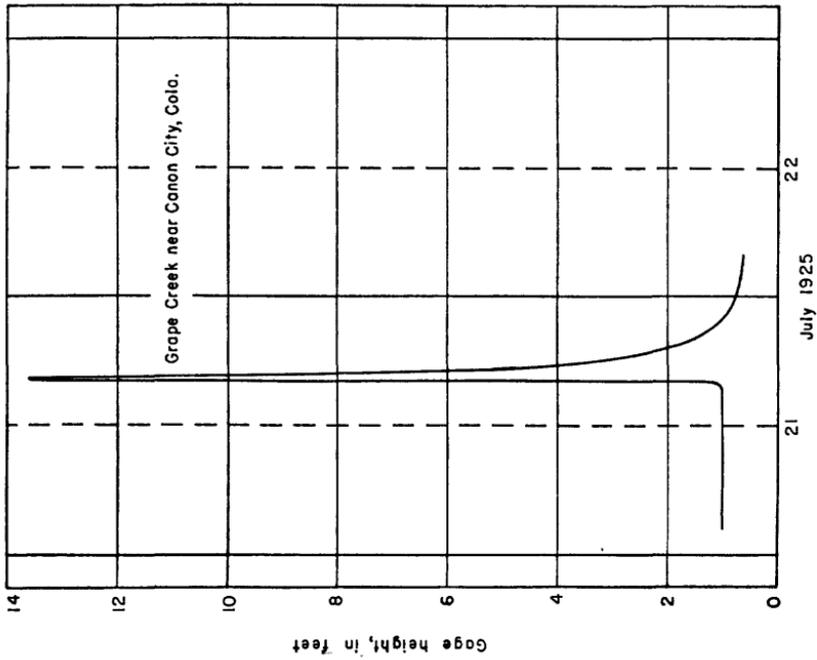
FIGURE 2.—Typical stage hydrographs of cloudburst floods.

The tributary streams in the South Platte and Arkansas River Basins are subject to heavy rains of cloudburst intensity which cause the cloudburst type of flood, the peak discharge of which is greater than that caused by rainfall during the period of melting snow. Whenever heavy rain occurs along the Front Range, particularly in the lower foothills, it is usually concentrated in cloudbursts at various points. The cloudburst flood flow is of such short duration, the peak lasting only a few minutes, and the total quantity of water during the flood is so small, that when it reaches a larger stream, channel storage quickly reduces it to a stage which is not a serious flood. This is well illustrated by the typical stage hydrographs shown in figure 2.

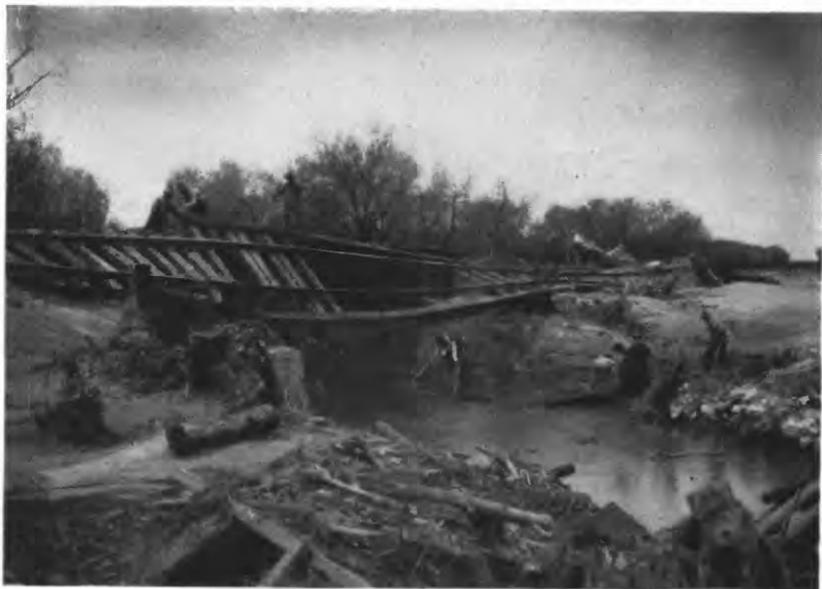
A. BRIDGE WEST OF PUEBLO.

DAMAGE TO DENVER & RIO GRANDE RAILROAD CAUSED BY FLOOD
OF JUNE 1921.

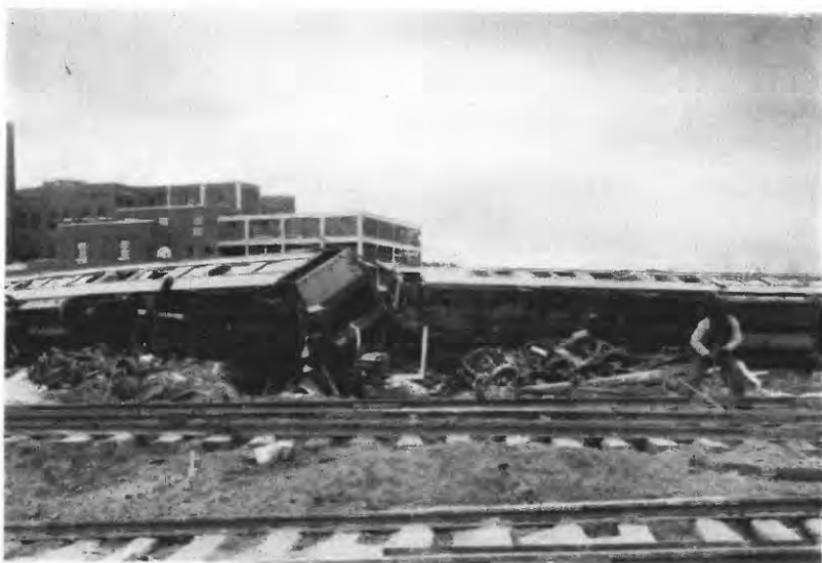
B. RAILROAD YARDS IN PUEBLO.

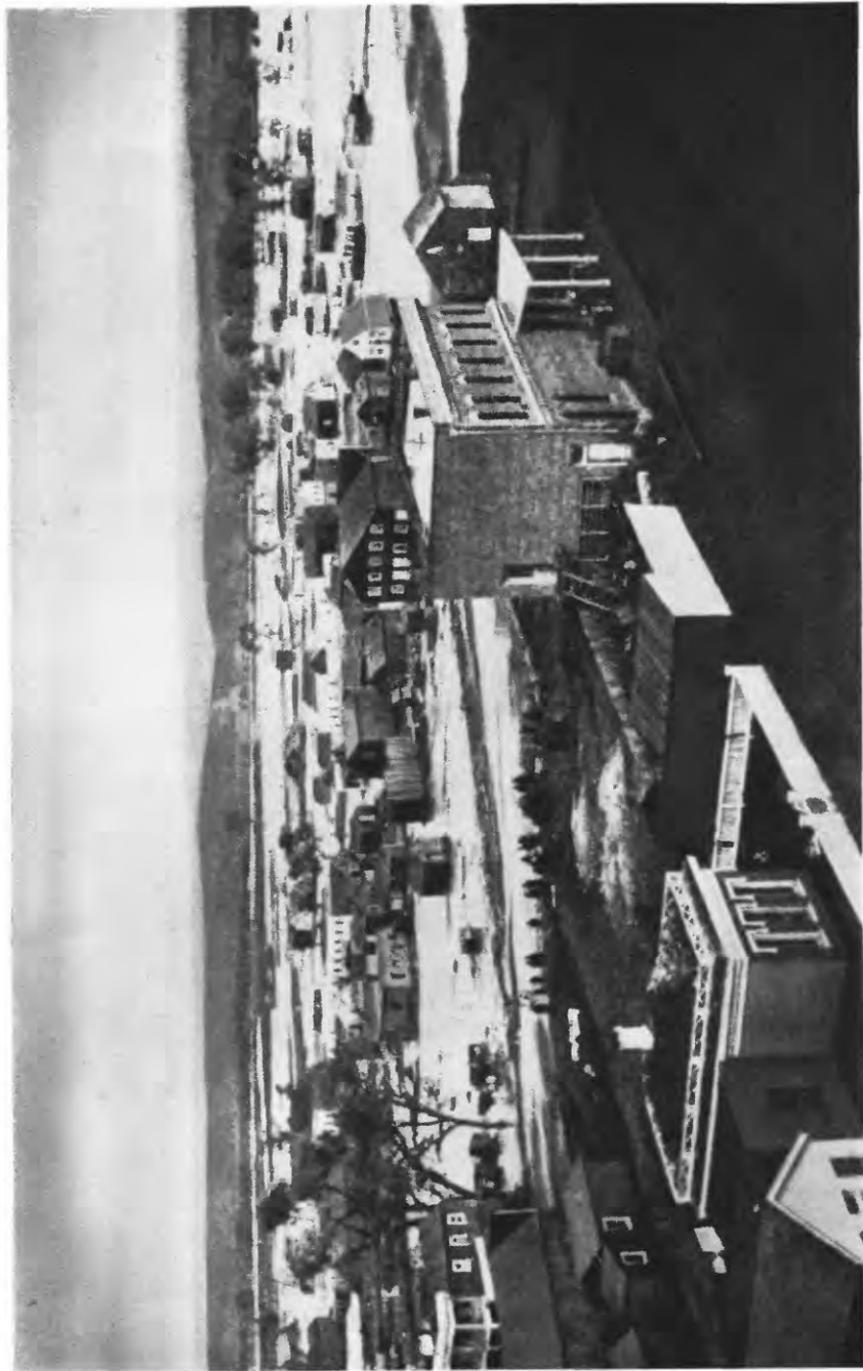
CITY OF DENVER DURING THE FLOOD OF MAY 19-20, 1864.

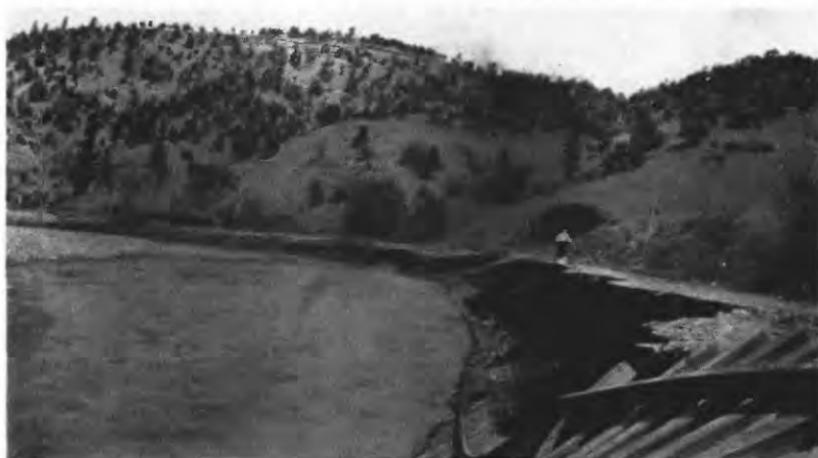
DAMAGE TO TRACKS OF DENVER & RIO GRANDE RAILROAD CAUSED BY FLOOD OF OCTOBER 1911 ON SAN JUAN RIVER NEAR PAGOSA JUNCTION.

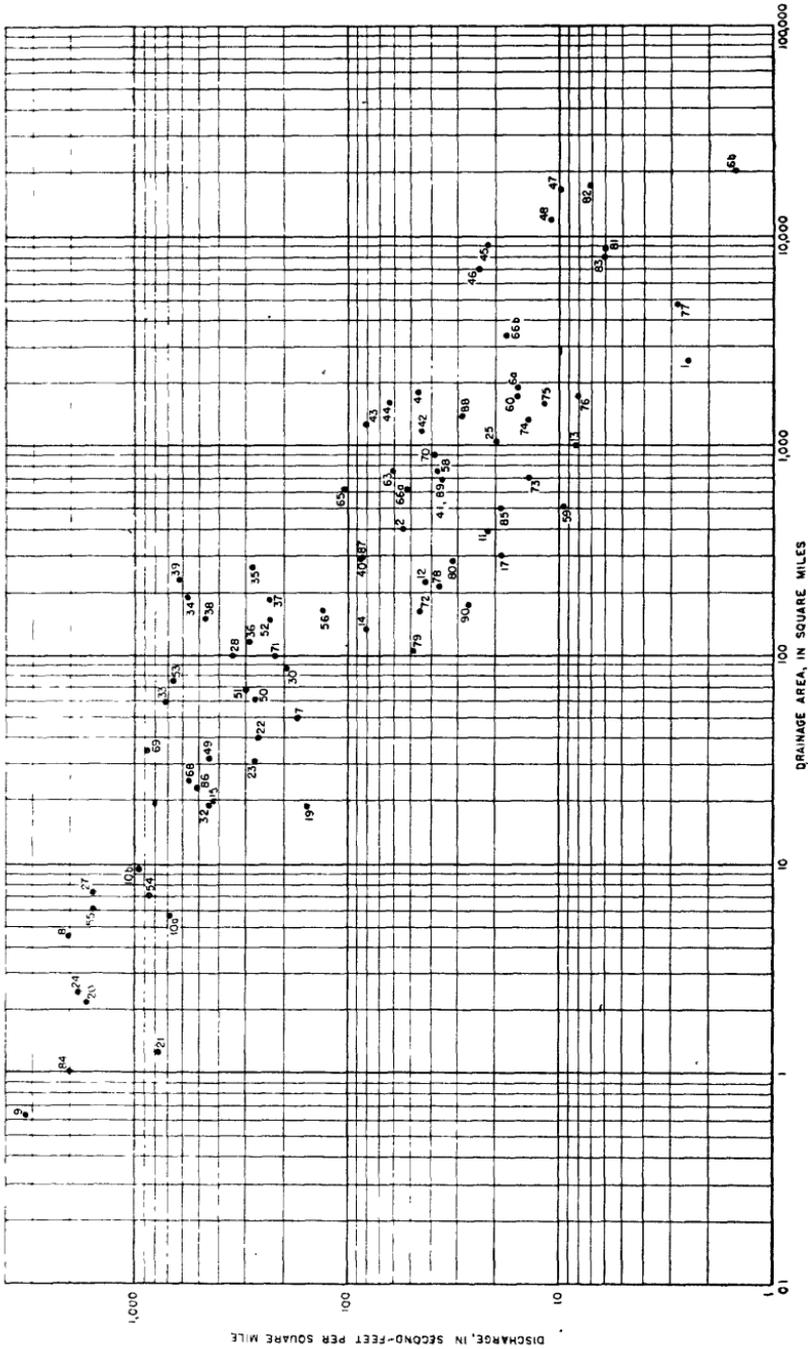
FIGURE 3.—Chart showing maximum flood discharge, in second-foot per square mile, for various places given in the summary table.

The following table shows the recorded peak discharges of the floods described in this report. If several floods at the same place are described, the peak discharge of the highest flood only is given. The period of record at regular gaging stations is not shown, as at most stations the flood recorded as the greatest is the greatest in a much longer period than that covered by the gaging-station records. In figure 3 the peak discharge in second-feet per square mile for each place is plotted against the corresponding drainage area.
