**Flood Hazard
Area Delineation
Plum Creek
East Plum Creek
West Plum Creek**

Urban Drainage and
Flood Control District

Douglas County

NOVEMBER 2019

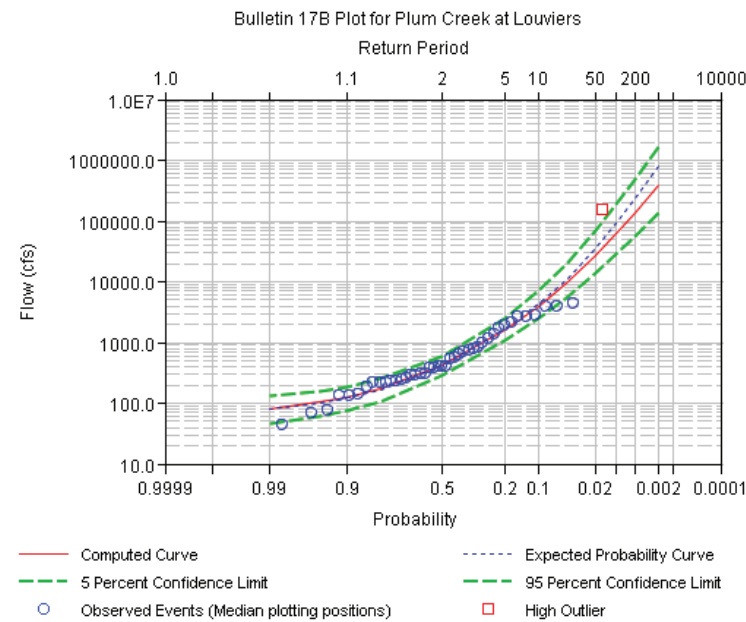
Figure 3: Flood Frequency Graph of a Bulletin 17B Analysis for USGS Gage 06709500 - Plum Creek near Louviers

- A statistical analysis using the Bulletin 17b method and the HEC-SSP program show the 100-year FIS flow within the confidence intervals for the gage at Titan Road.

This study is based on hydrology presented in the 2005 FIS. The methodology included in the 2005 FIS was reviewed in addition to other studies from CH2M HILL and WRC. There are no observed reasons from prior flood events or from review of the 2005 FIS methodology that necessitates an adjustment to the 2005 FIS flows at the time of this study. A statistical analysis including 43 years of annual peak data on Plum Creek indicate that the 100-year FIS flows fall within the lower band of confidence intervals for the USGS gauge near Louviers Avenue (North Main Street). If the 1965 flood event is removed from the data set, the 100-year FIS flows are considerably reduced, however, it is not appropriate to completely remove the 1965 flood event from the statistical analysis but instead to perform the outlier test and handle the outlier according to methodology in Bulletin 17B published by the USGS. **Table 6** presents the flow rates applied for this study while **Table 7** presents the computed flood frequency results for the gage near Louviers, Colorado.

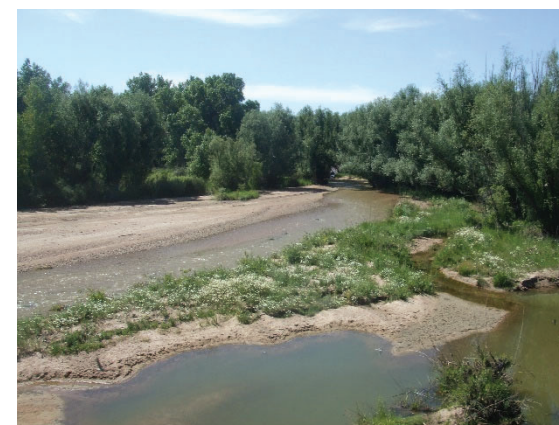
Figure 8: Plum Creek Main Channel Sandy Bed Outcrops Mixed with Vegetation ($0.035 < n < 0.045$)

- Main Channel (Braided with Sandy Gravel Bottom), $0.025 < n < 0.030$
- Main Channel (Moderately Confined with Riffles), $0.030 < n < 0.040$
- Main Channel (Sandy Bed Outcrops and Mixed Vegetation), $0.035 < n < 0.045$
- Overbank near Channel (Wheat Grasses, Willows, and Moderate Understory), $0.05 < n < 0.06$
- Overbank near Channel (Short Grasses, sandy coverage), $0.025 < n < 0.035$
- Overbank near Channel (Wetland Cattails, Medium Dense Brush), $0.070 < n < 0.12$
- Far Overbank (Mixed Trees with Tall Grasses in Between), $0.085 < n < 0.12$
- Far Overbank (trees, brushes, grasses, and moderately dense understory), $0.050 < n < 0.065$
- Far Overbank (Light Trees, Short Grasses, Sandy Bottom), $0.035 < n < 0.045$
- Far Overbank with light grasses and Sandy Bottom, $0.04 < n < 0.055$
- Far Overbank (Sandy bottom and well-established brush), $0.045 < n < 0.055$

The images on the next few pages (**Figures 5 to 14**) document the land use and vegetative characteristics for each Manning’s n value presented above.

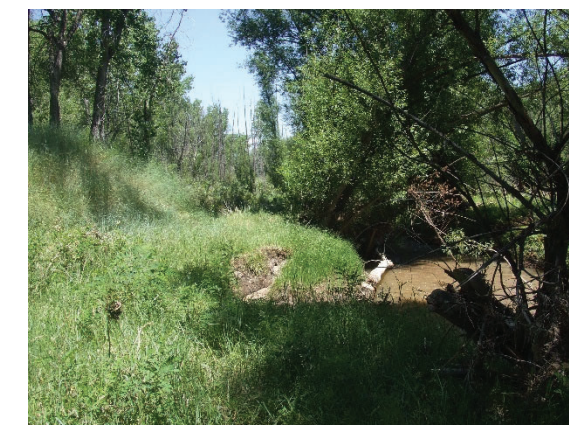
Figure 7: Plum Creek Main Channel Overbank near Channel Wheat Grasses, Willows, and Moderate Understory ($0.050 < n < 0.060$)

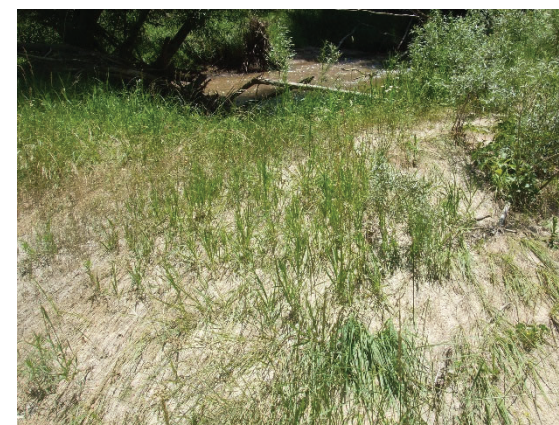
Figure 9: Plum Creek Main Channel Overbank near Channel with Wetlands, Grasses, and Medium Dense Brush ($0.070 < n < 0.12$)

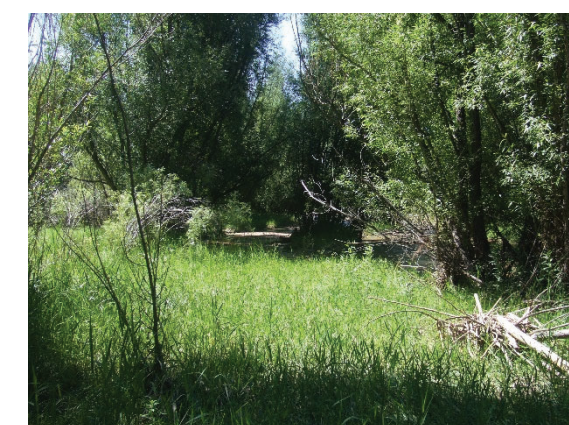
Figure 10: Plum Creek Main Channel Overbank near Channel Short Grasses and Sandy Coverage ($0.025 < n < 0.035$)

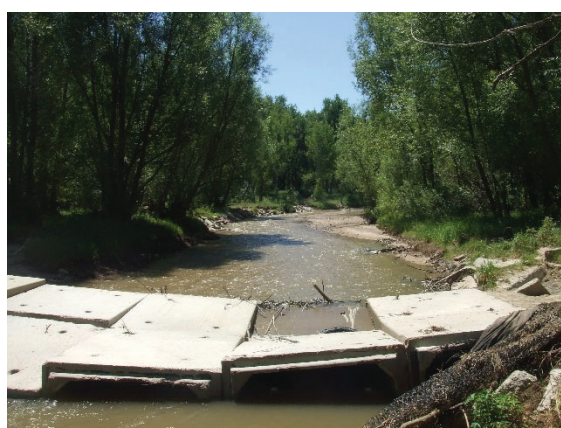
Figure 5: Plum Creek Main Channel Braided with Sandy Bottom ($0.025 < n < 0.030$)

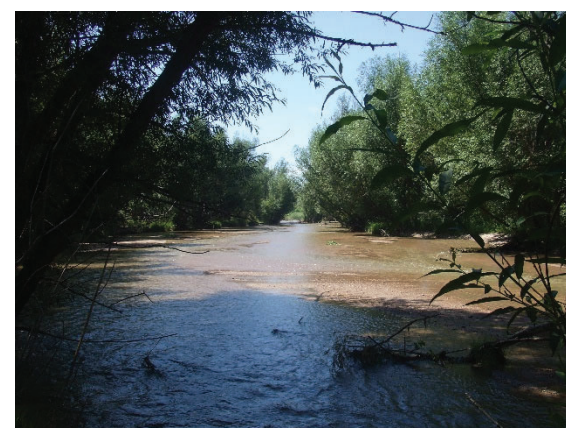
Figure 6: Plum Creek Main Channel Moderately Confined with Riffles ($0.030 < n < 0.040$)

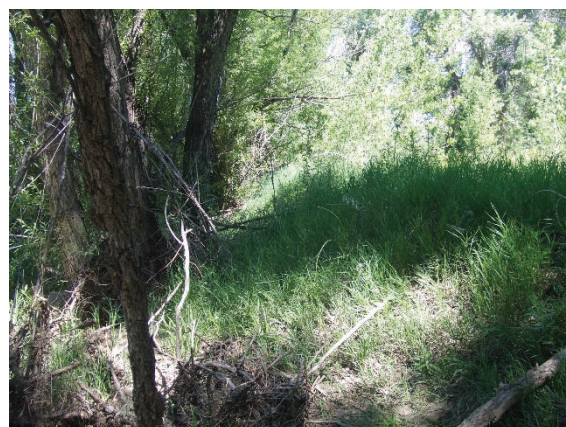
Figure 11: Plum Creek Main Channel Far Overbank with Mixed Trees and Tall Grasses (0.025<n<0.030)

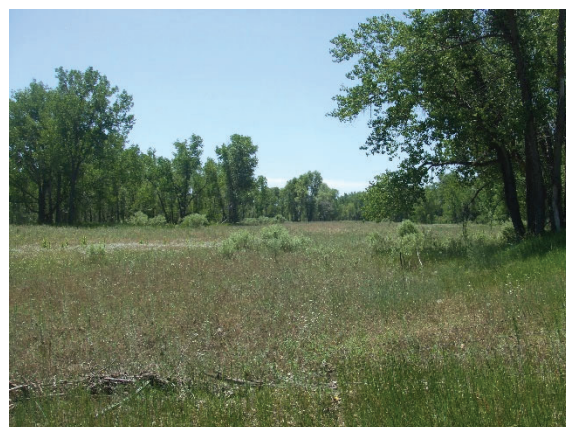
Figure 14: Plum Creek Main Channel Far Overbank with Light Trees, Short Grasses and Sandy Bottom (0.035<n<0.045)

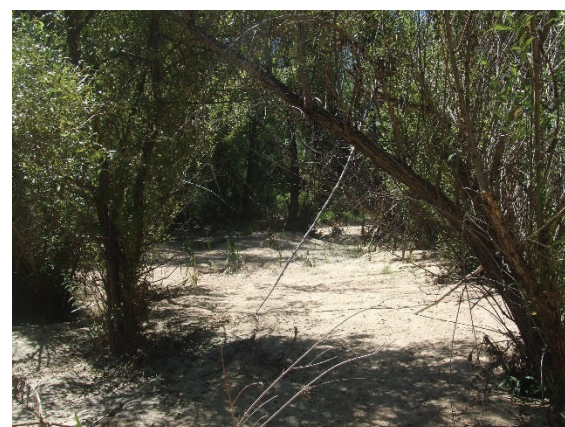
Figure 13: Plum Creek Main Channel Far Overbank with Light Grasses, Sandy Bottom (0.040<n<0.050)
