Flood Hazard Area Delineation Goldsmith Gulch

October 2022

**RE: Goldsmith Gulch Flood Hazard Area Delineation Report
Agreement No. 18-01.20**

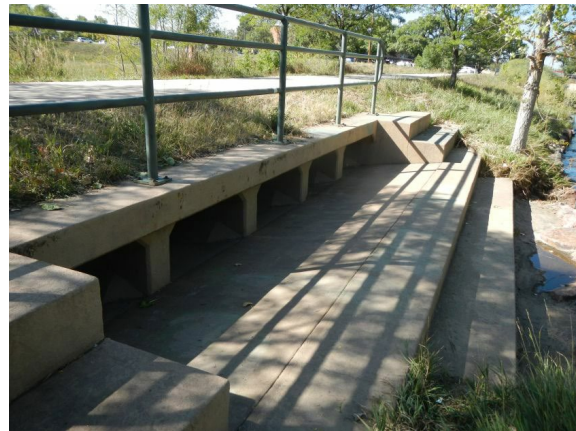
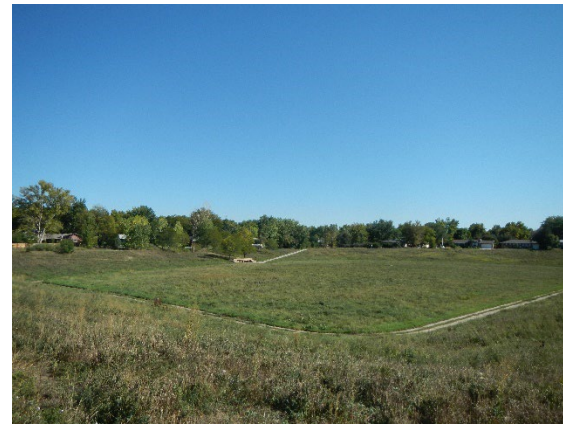
Figure 2-3 Iliff & Monaco Detention.

Basin inlet looking northwest.

Basin looking southeast, outlet pump at left corner

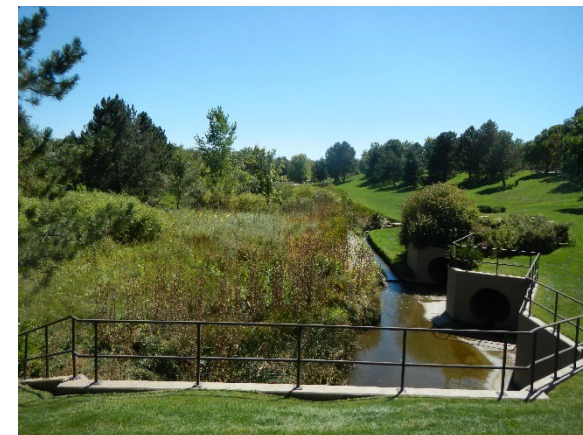
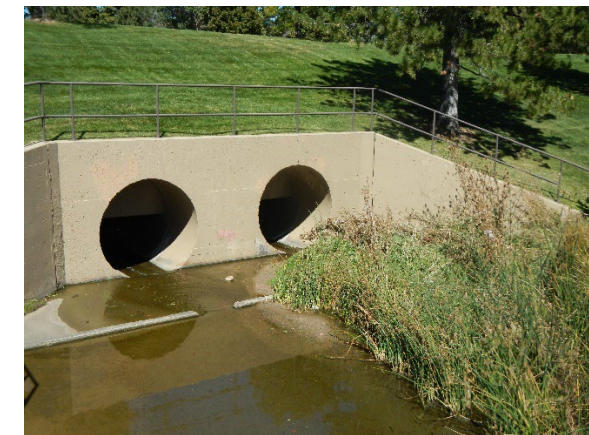
Figure 2-4 Wallace Park South Detention.

Basin looking south from the outlet.

Basin outlet looking north.

From Belleview Avenue to E. Temple Drive, the gulch flows through Wallace Park South, which also acts as a detention. The Wallace Park South Detention Basin (see **Figure 2-4**) outlet consists of two 7-foot diameter concrete pipes with restrictor plates extending 2.75-feet from the top of pipe (4.25-foot opening), providing detention only. Six drop structures are located within this section.

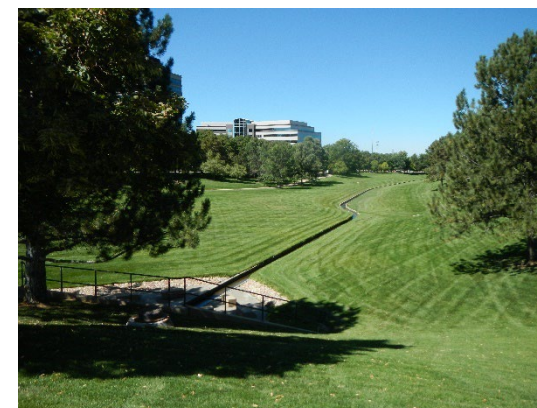
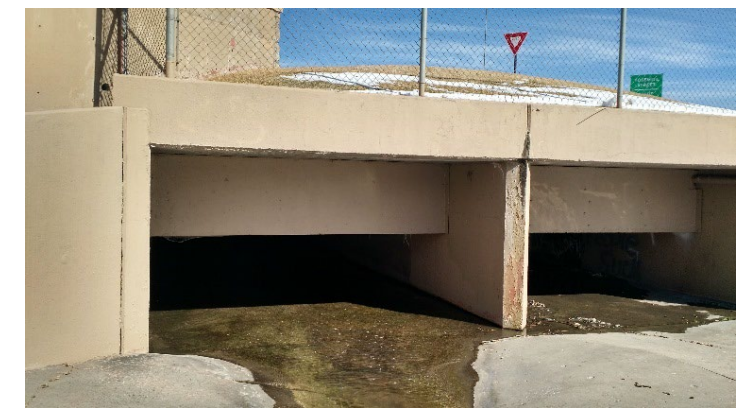
Figure 2-5 Wallace Park North Detention.

Basin inlet looking north.

Basin outlet looking north.

From E. Temple Drive to I-225, the gulch flows through Wallace Park North, which also acts as a detention basin. The Wallace Park North Detention (see **Figure 2-5**) outlet consists of two 12-feet by 6-feet concrete box culverts with restrictor plates extending 3-feet from the top of pipe (3-foot opening), providing detention only.

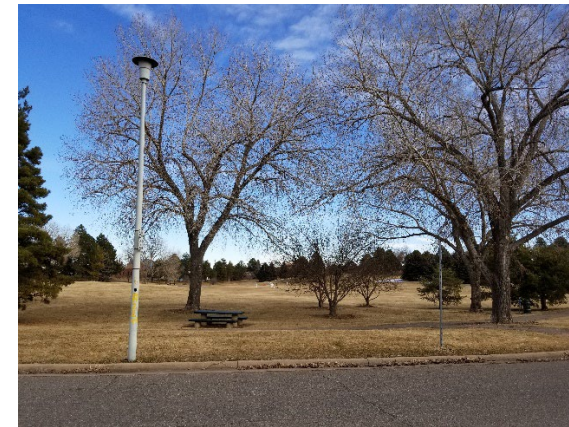
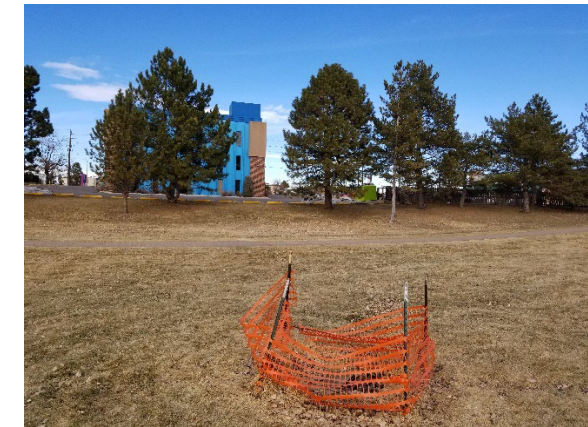
Figure 2-6 Southmoor Park Detention.

Basin inlet looking east (surface flow).

Basin outlet and spillway looking north.

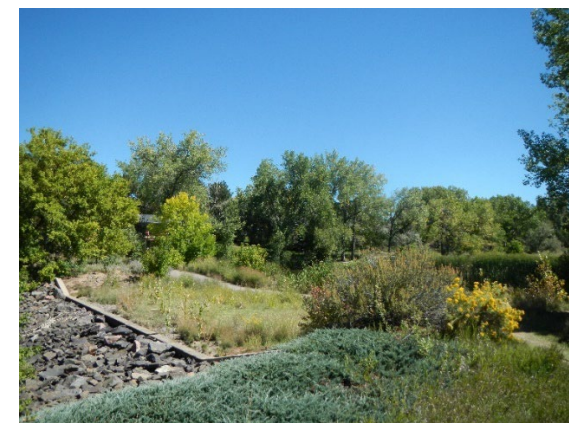
Figure 2-7 Orchard Hills Detention.

Basin outlet looking north.

Basin spillway looking east.

The confluence of West Fork Goldsmith Gulch and Goldsmith Gulch is located in Orchard Hills Park directly upstream of Orchard Hills Detention Basin (see **Figure 2-7**). This basin includes a permanent wet pool. An 18-inch stand pipe conveys low flows downstream creates permanent wet pool. Larger flows spill over a pedestrian trail. Increasing storage volume at this location is evaluated as part of the alternatives analysis.

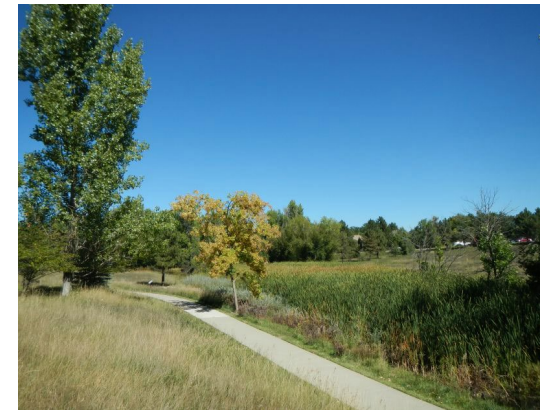
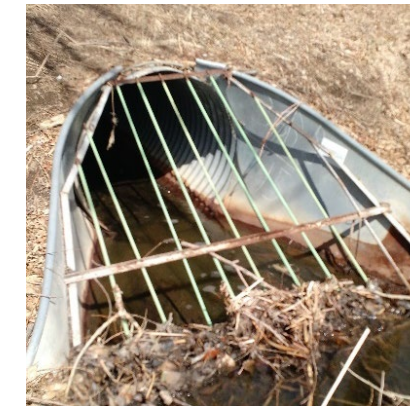
Figure 2-8 Silo Park Detention.

Basin looking north.

Basin outlet looking north.

The Silo Park Detention Basin (see **Figure 2-8**) is currently being redesigned. The existing basin outlet structure consists of one 36-inch CMP pipe and provides detention only. The proposed design increases the size of the culvert under Orchard Road to reduce overtopping and thus will also integrate a spillway berm upstream of Orchard Road to mimic existing detention, similar to Tommy Davis Park. The implementation of the proposed Silo Park Drainage Improvement Project is scheduled to be constructed by 2022.

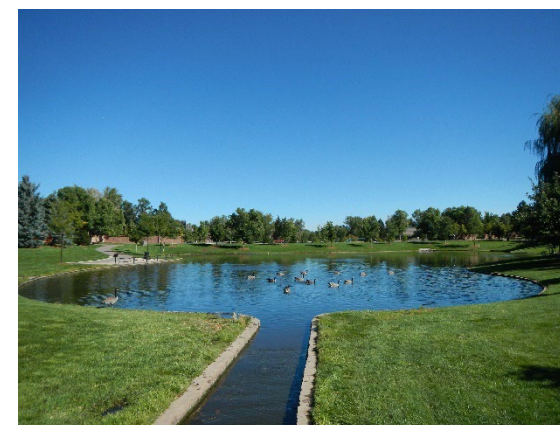
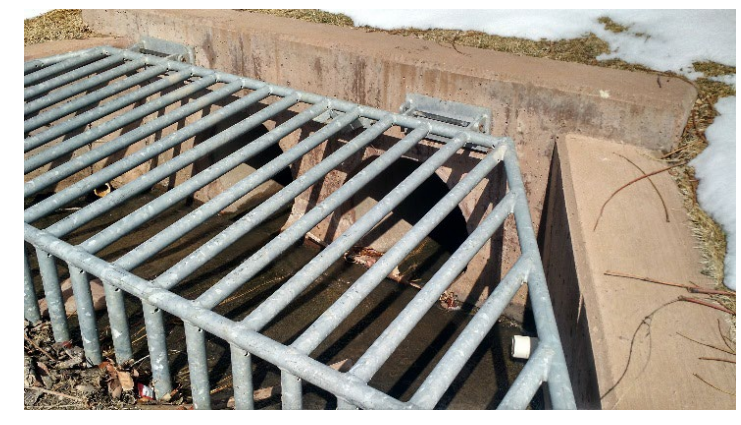
Figure 2-9 Tommy Davis Park Detention.

Basin and inlet looking north.

Basin outlet looking north.

A concrete low flow channel extends from Maplewood Avenue to the Tommy Davis Park Detention Basin at Orchard Road and includes three drop structures. The Tommy Davis Park Detention Basin (see **Figure 2-9**) was constructed in 2008 and the 16-feet by 10-feet RCBC and pedestrian crossing at Orchard Road was completed in 2009. Both phases are documented in as-builts (*As-Builts: Goldsmith Gulch – West Tributary Tommy Davis Park Phase I Improvements, 2008, and Phase II Improvements, 2009*). The basin is designed for detention only and includes a permanent wet pool below the outlet. The basin outlet structure consists of two 24-inch pipes and spillway berm, both located upstream of the Orchard Road culvert.

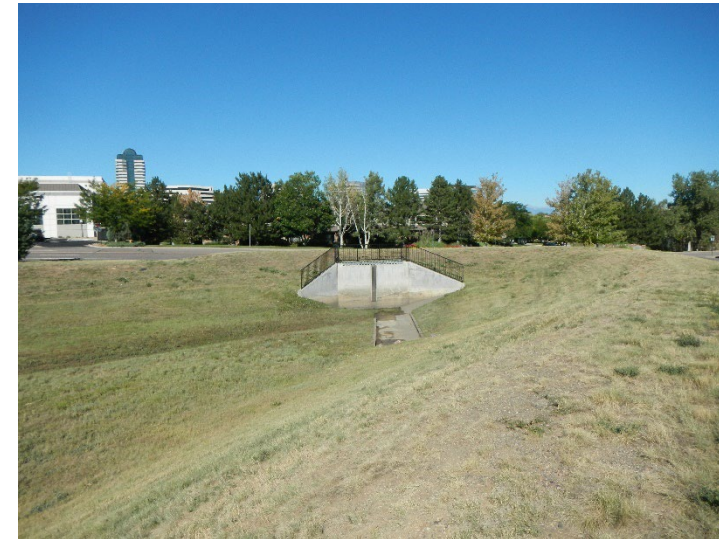
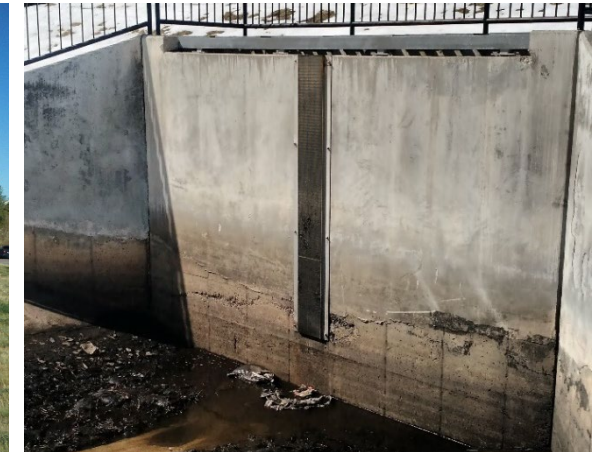
Figure 2-10 Boston Peakview Detention.

Basin and outlet looking north.

Basin outlet looking north.

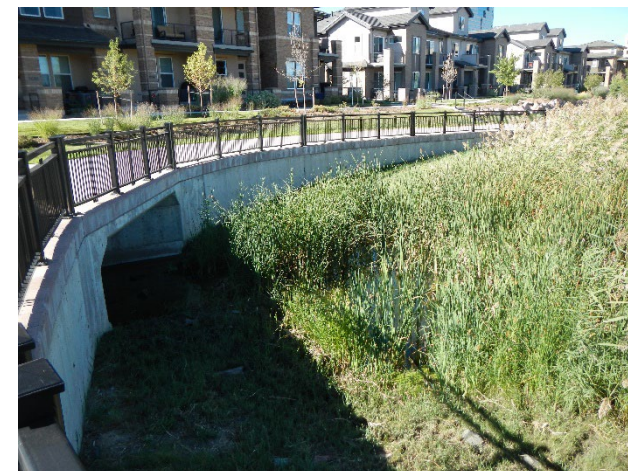
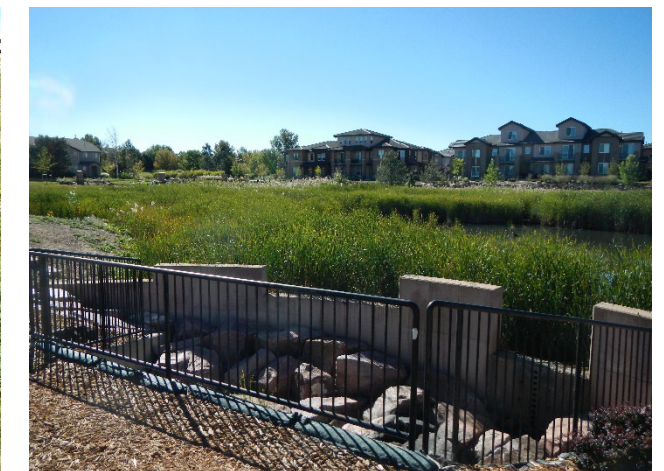
Figure 2-11 Caley Detention.

Basin inlet looking south.

Basin outlet looking south.

Caley Detention Basin (see **Figure 2-11**) was constructed in 2004 to provide regional detention and water quality and is documented in as-builts. The adjacent pedestrian underpass was completed in 2017. The basin outlet structure consists of multi-level weirs with an orifice plate in the lowest weir to provide water quality. Once water overtops the weir structure, it is conveyed through two 6-foot by 4-foot RCBC across E. Caley Avenue. A LOMR is complete for the recently installed box culvert at the inlet to Caley basin. Caley Detention Basin is not designed to spill into the pedestrian underpass, however, since the wall is not considered a levee, the regulatory floodplain extends into this underpass. A drop structure was located at the current inlet of Caley Detention Basin and served as energy dissipation at the inlet. The project removed the drop structure and replaced it with

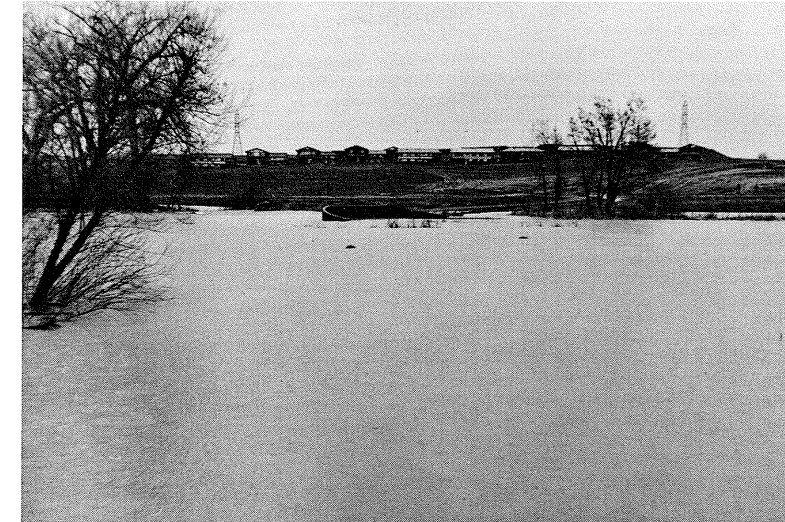
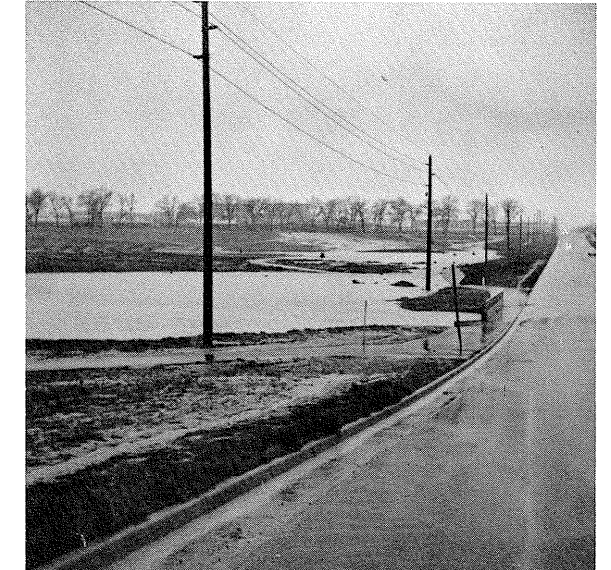
Figure 2-14 1973 Flooding Event

Goldsmith Gulch at Dartmouth Avenue and High Line Canal, May 6, 1973. View looking downstream.

Goldsmith Gulch at Yale Avenue, May 6, 1973. View looking west along Yale Avenue.

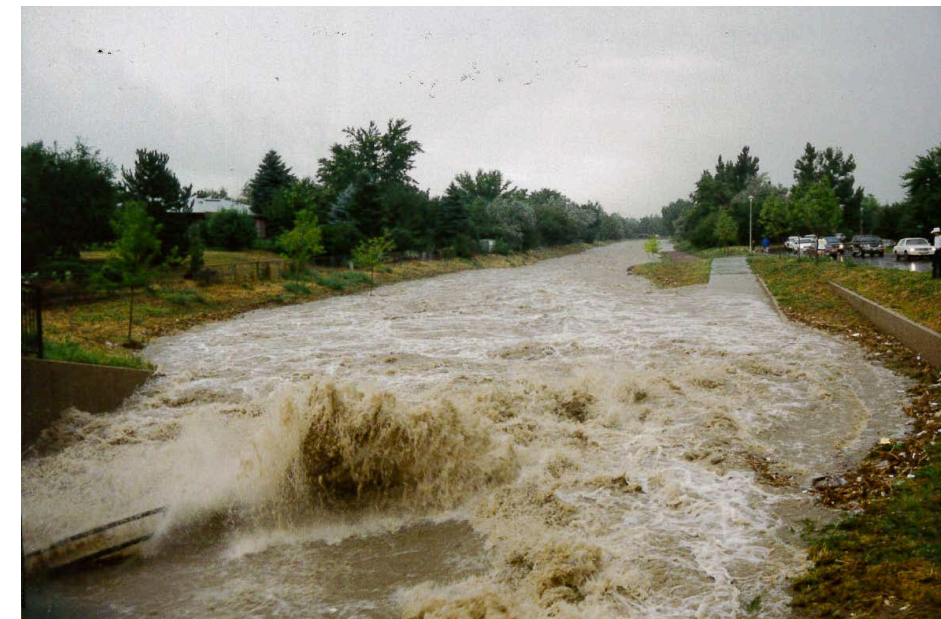
Figure 2-15 Goldsmith Gulch downstream of Yale Avenue on July 28, 1997

On July 27, 1997, Goldsmith Gulch was hit by heavy rains with 1.66 inches falling at the Denver Tech Center. Downstream floodwaters approached 10-year levels causing the side-channel detention facility, constructed a year earlier in 1996 near Iliff Avenue and Monaco, to activate and was credited with preventing damages downstream. A minor glitch did occur, however, when the pump that drains the facility failed to start.

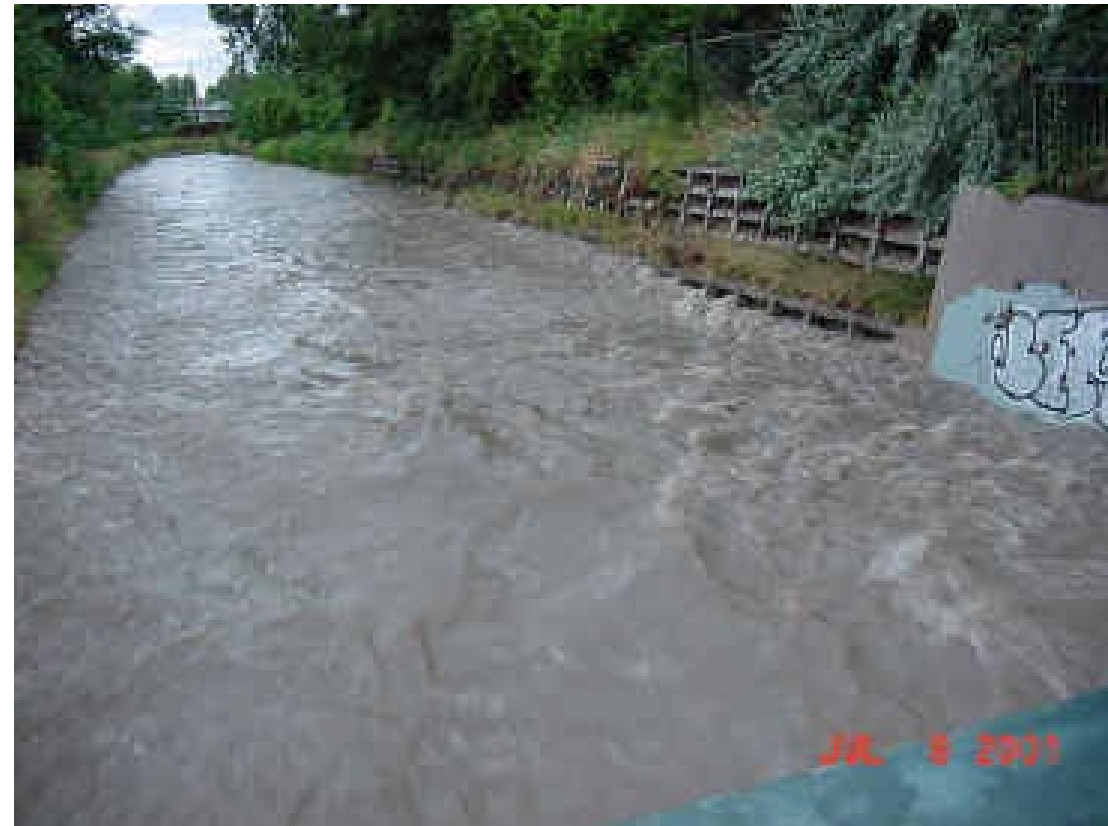
Figure 2-16 Goldsmith Gulch upstream of Mexico Avenue on July 8, 2001

On July 8, 2001, significant flooding again occurred. Up to 4.5 inches of rain fell across portions of western Arapahoe County. The underpass of Interstate I-225 and Parker Road was inundated with 5 feet of water. **Figure 2-16** illustrates conditions at Goldsmith Gulch upstream of Mexico Avenue during the 2001 flood.

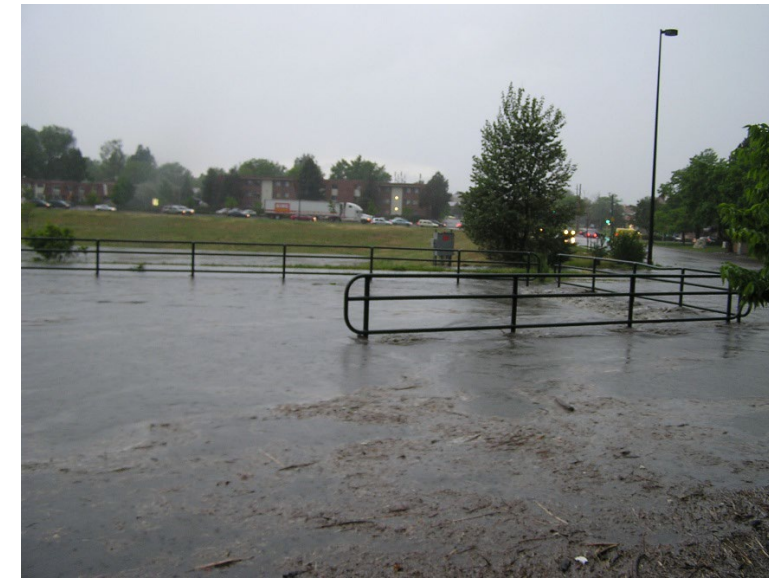
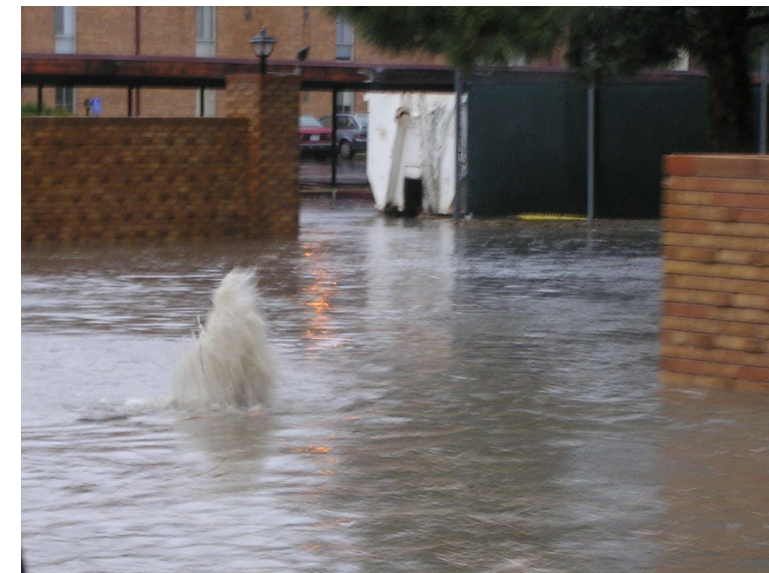
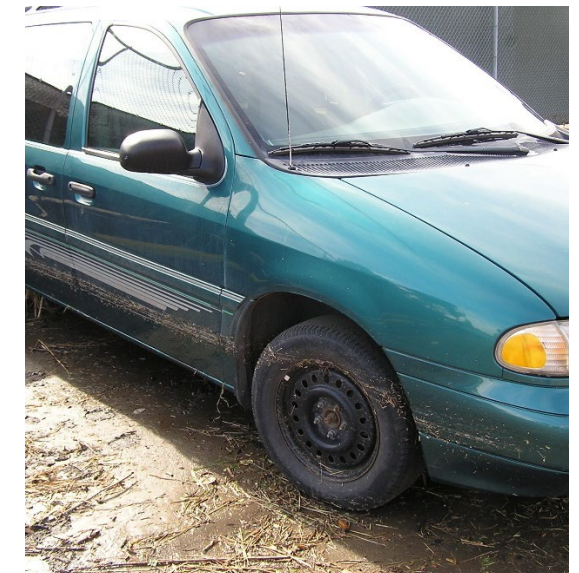
Figure 2-17 June 3, 2005 Flooding Event.

Goldsmith Gulch at Iliff Avenue looking west along Iliff Avenue towards the detention basin.

Goldsmith Gulch upstream of Iliff Avenue looking west towards the detention basin.

Goldsmith Gulch in the parking lot of the apartment complex on the north side of Iliff Avenue.

Water level in apartment complex parking lot.

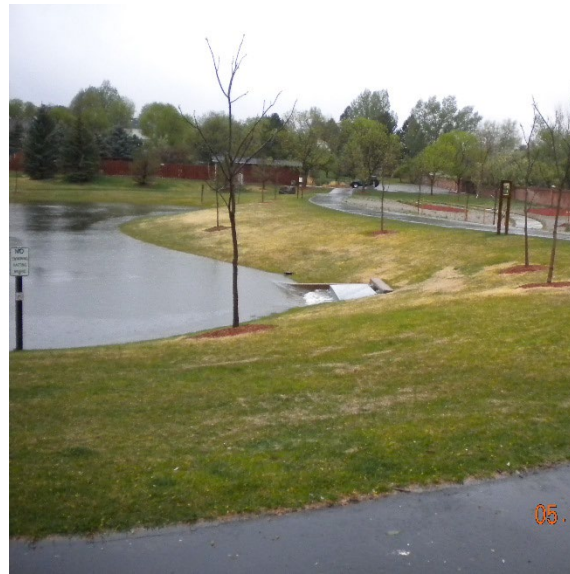
Tommy Davis Park detention outlet (on south side of berm) looking west.

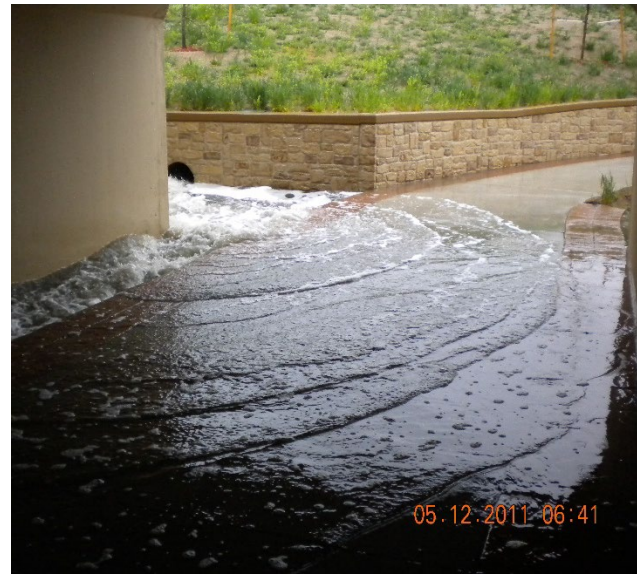
Tommy Davis Park detention outlet (on north side of berm in underpass) looking south.

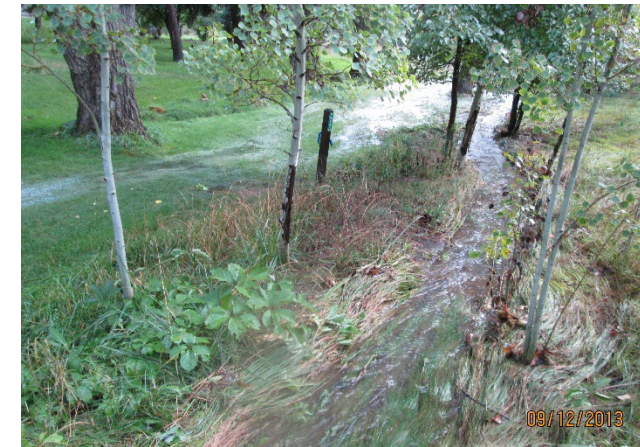
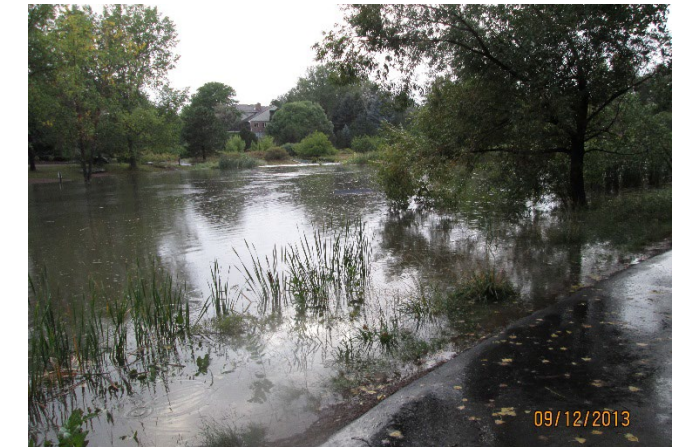
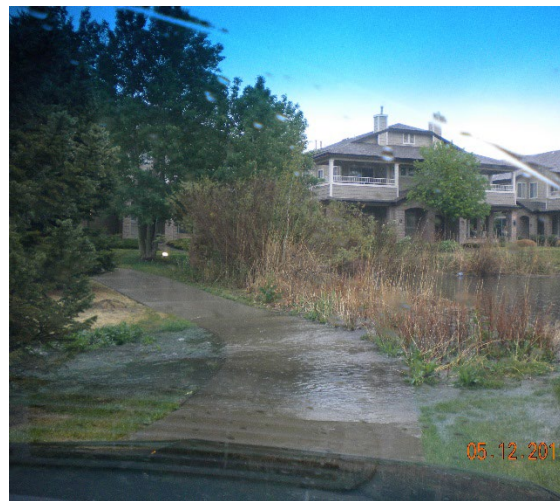
Figure 2-18 May 12, 2011 Flooding Event.

Orchard Hills Park

Orchard Hills Park.

Flooding was also noted on August 13, 2006, May 12, 2011 (**Figure 2-18**), July 13-14, 2011, and June 11, 2015 (**Figure 2-19**), according to the gage records, but no specific information is available regarding flood impacts.

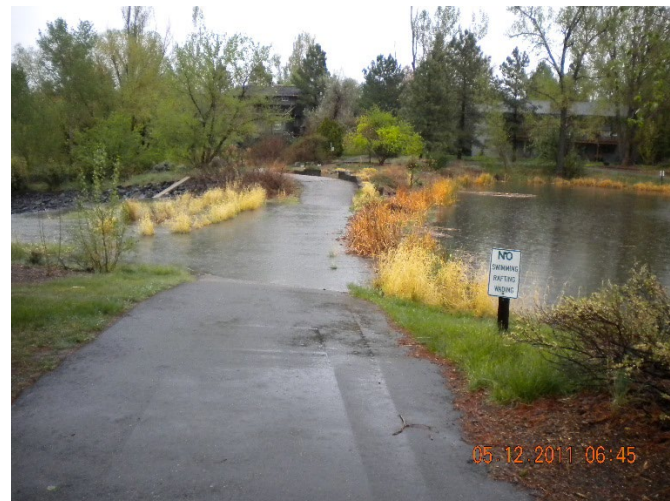
Orchard Hills detention spillway looking east.

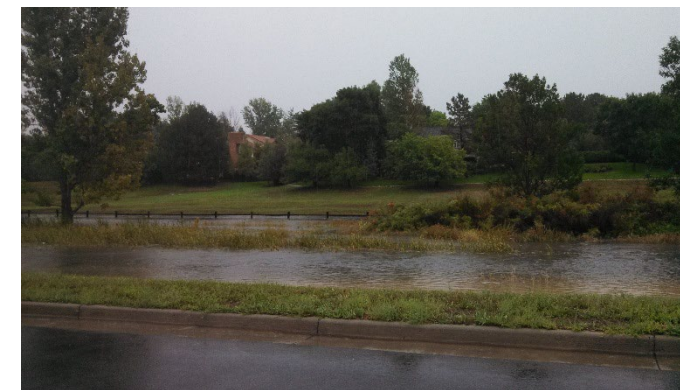
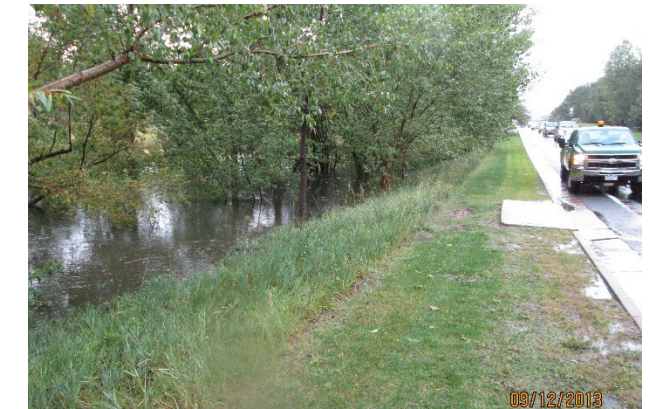
Figure 2-19 September 12, 2013 Flooding Event.

Downstream of Berry Stables

Silo Park Basin

A major event occurred on September 12, 2013 (**Figure 2-19**). According to the UDFCD 2013 Flood Peak Estimate Interactive Map, flows reached 420 cfs at Wallace Park South Detention Basin, 752 cfs at Goldsmith Gulch at Eastman Avenue, and 461 cfs at Iliff & Monaco Detention Basin.

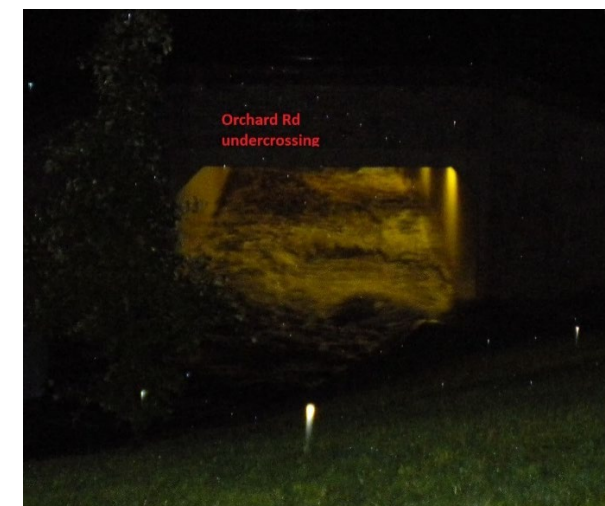
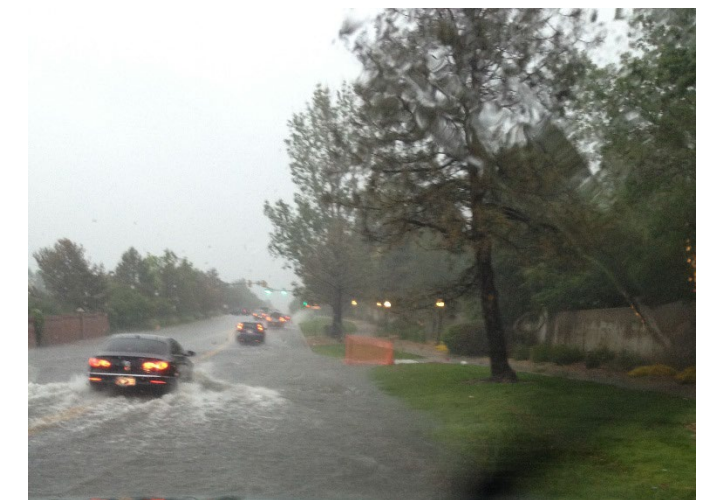
Figure 2-20 June 11, 2015 Flooding Event.

Orchard Road Under Crossing at West Tributary

Dayton Street at Goldsmith Gulch

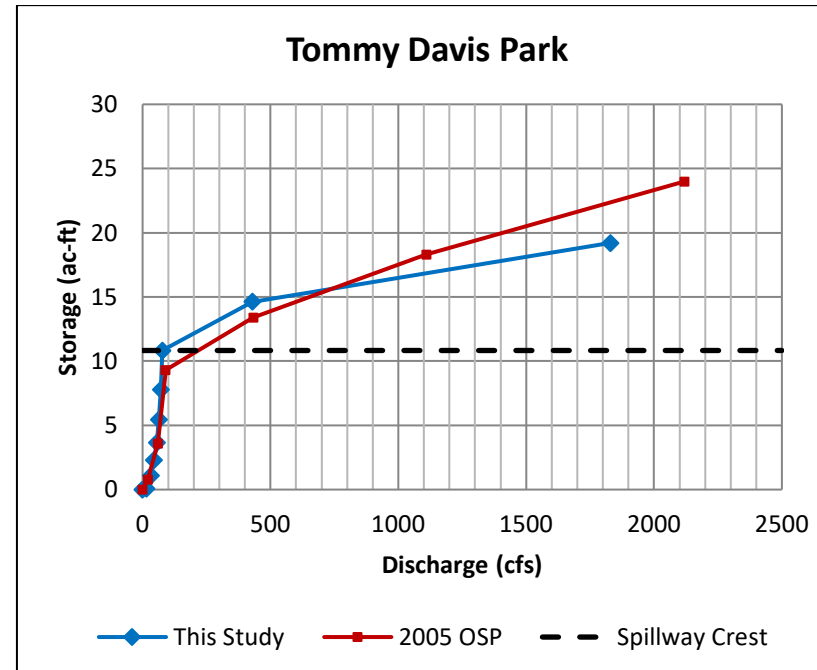
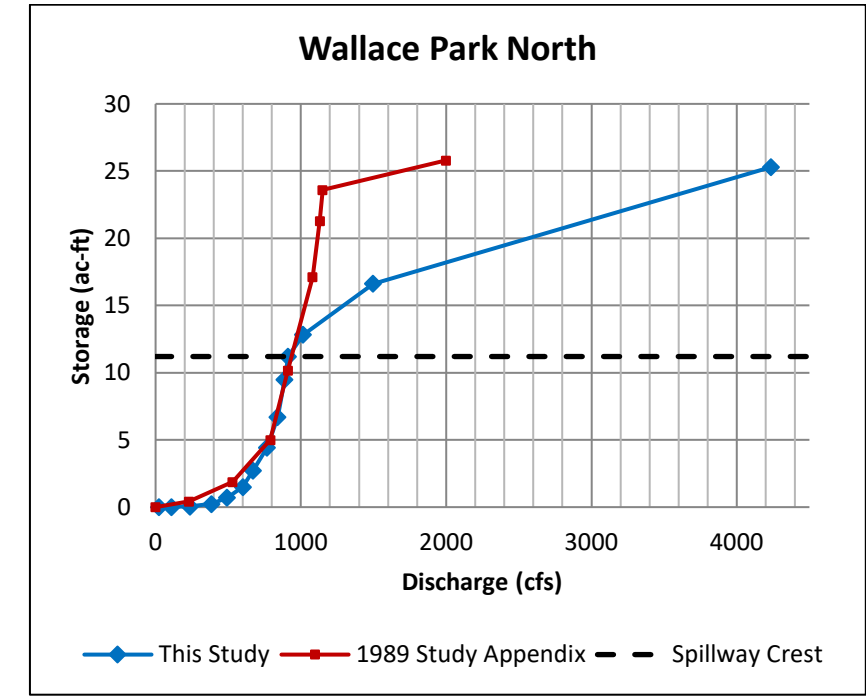
Figure 3-2 Detention Rating Curve Comparison.

Note: Dashed black line is 2018 Spillway Crest elevation.
