Log Drop Evaluations at Timbers Creek and Rock Creek

Mile High Flood District

October 08, 2021

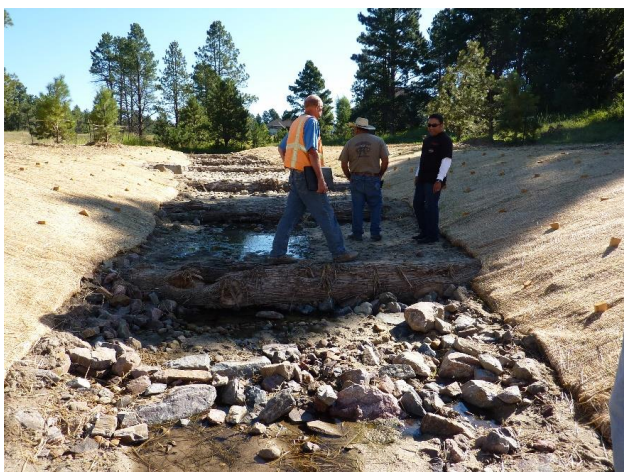
Figure 3: Original Design

The logs were attached to concrete anchors for buoyancy resistance and the ends were buried under soil, with the channel bottom forming a traditional trapezoidal shape. Standard soil riprap was used upstream, downstream, and on the sides of the drop structure (see Figure 3). Cobbles were added to the soil riprap to provide a more natural cobble appearance. The upstream and downstream logs incorporated sheetpile with a concrete cap, which were integrated into the concrete anchors. Please refer to the 2011 Case Study, found in **Appendix F**, for additional information including the basis for the concept, a summary of design elements, a summary of construction efforts, and recommendations for future log drop structure installations.

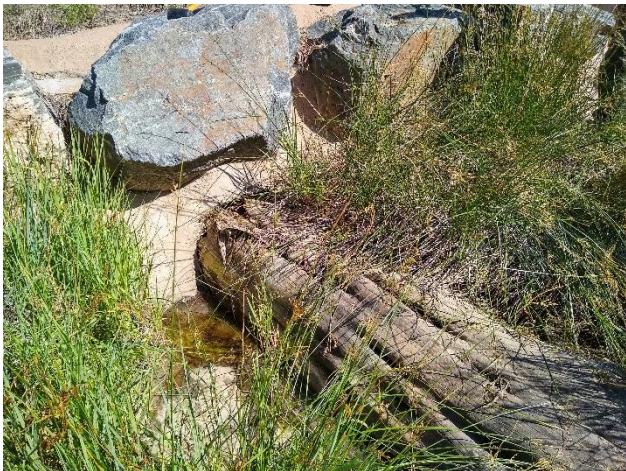
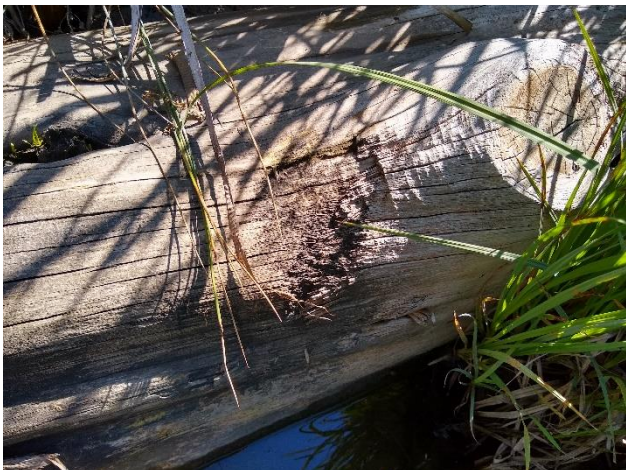
The interface between the logs and the grouted boulder channel edging appear to be in good condition throughout the structure. However, the north end of Log #5, as seen in photos 5.1 and 5.5, shows evidence of a small gap in the grout. The grout was installed over the outer bark and as the outer bark has deteriorated with time, a gap between the grout and the inner wood is evident.

- Logs can be obtained in a milled form with the outer bark removed, or in their native form with the outer bark intact. The outer bark provides some natural and aesthetic values. If it is determined that the outer bark should remain, it is recommended that the outer bark be removed from those sections of the logs that are to be buried and/or tied into a hard, engineered feature such as grouted boulders. This work should be done on-site by the contractor. This course of action serves to minimize issues encountered at the interface.
